**Ross Valley Sanitary District**

**Sewer System Replacement Master**

**Draft Final Report**

**January 2007**

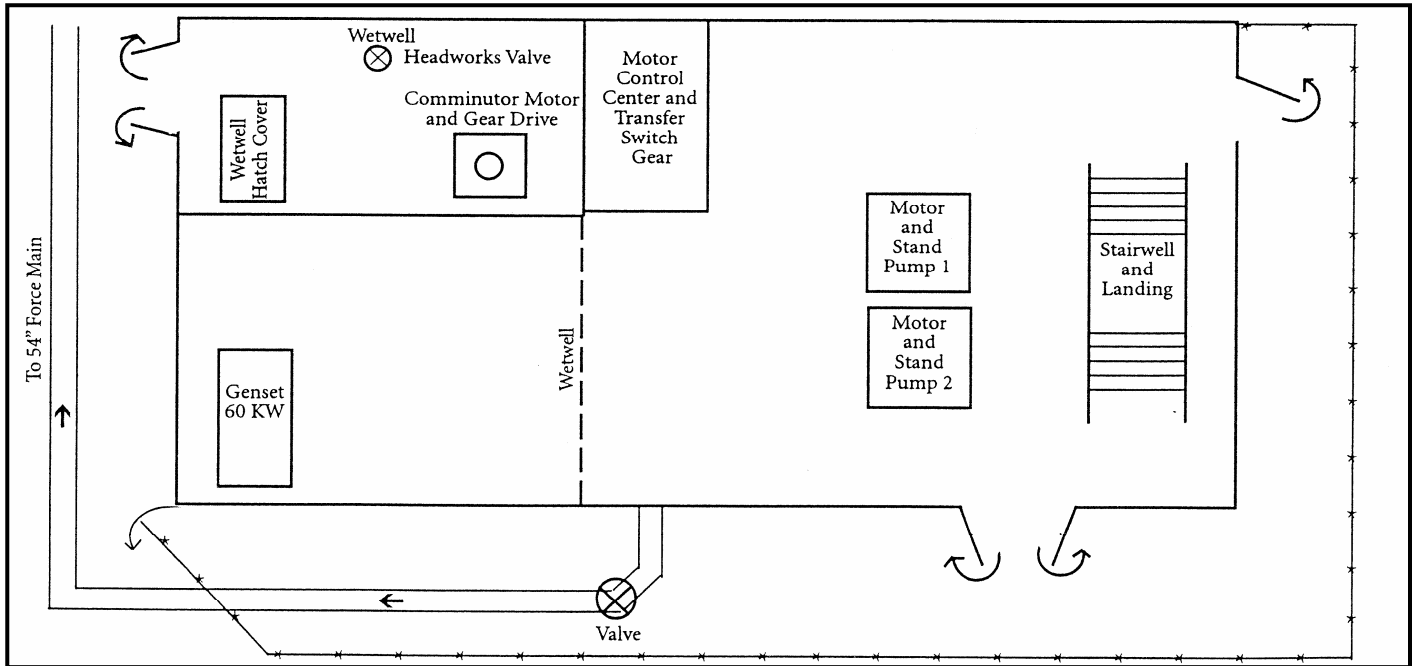
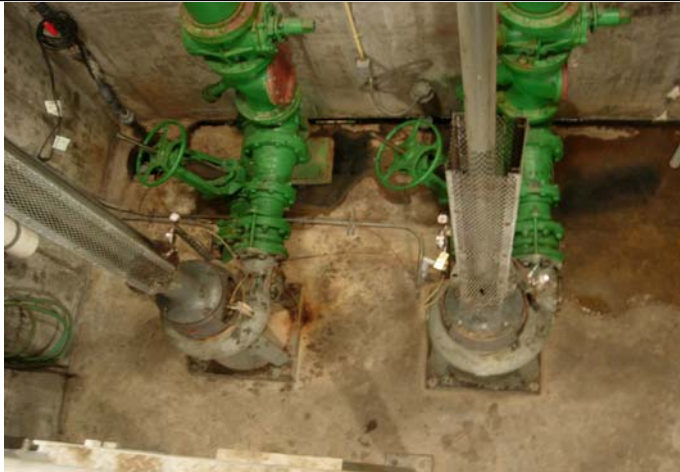
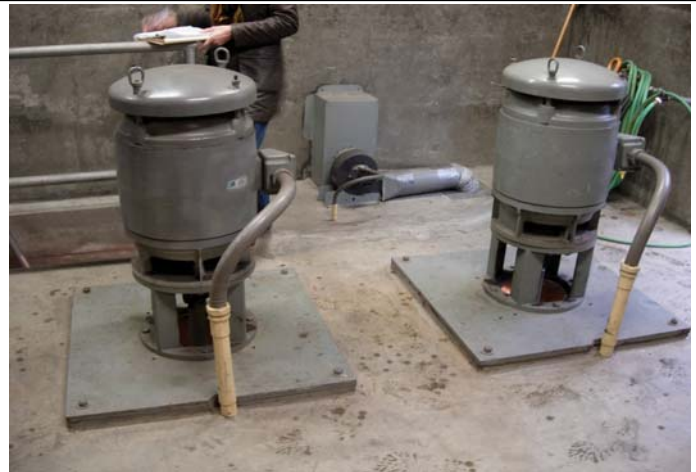
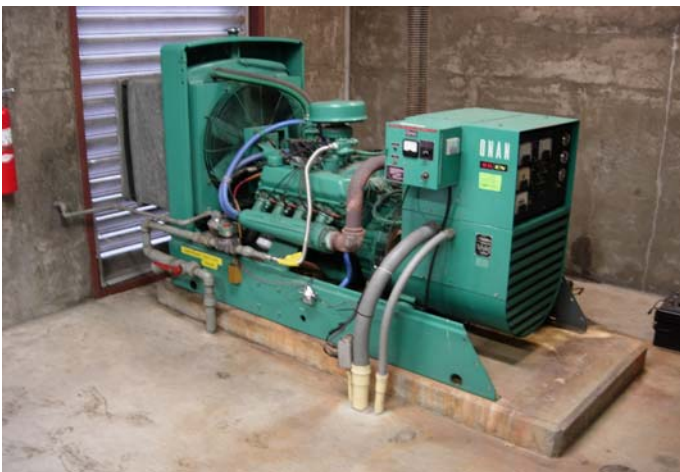
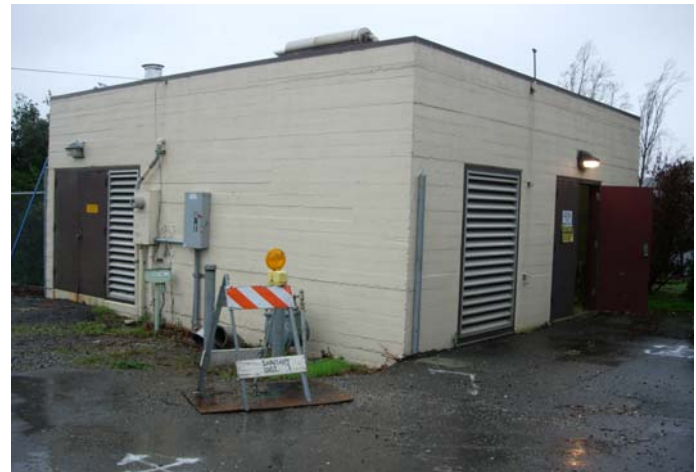
<b>Notes</b>	<ul style="list-style-type: none"> <li>• Pump station is planned for rehabilitation. Cost of rehabilitation is approximately \$1.0 million.</li> </ul>
<b>Identified Issues</b>	<ul style="list-style-type: none"> <li>• Pump enclosure is not well ventilated.</li> <li>• Water system has no back flow preventer.</li> </ul>
<b>Recommendations</b>	<ul style="list-style-type: none"> <li>• <b>Piping &amp; Valving:</b> NA</li> <li>• <b>Electrical:</b> NA</li> <li>• <b>Instrumentation &amp; Control:</b> NA</li> <li>• <b>Structural:</b> NA</li> <li>• <b>Health &amp; Safety:</b> NA</li> <li>• <b>Neighborhood Nuisance:</b> NA</li> <li>• <b>Pumps Improvement:</b> NA</li> <li>• <b>Influent Sewer/Force Main:</b> NA</li> <li>• <b>Maintenance/Reliability:</b> NA</li> <li>• <b>Overflow Potential:</b> NA</li> </ul>

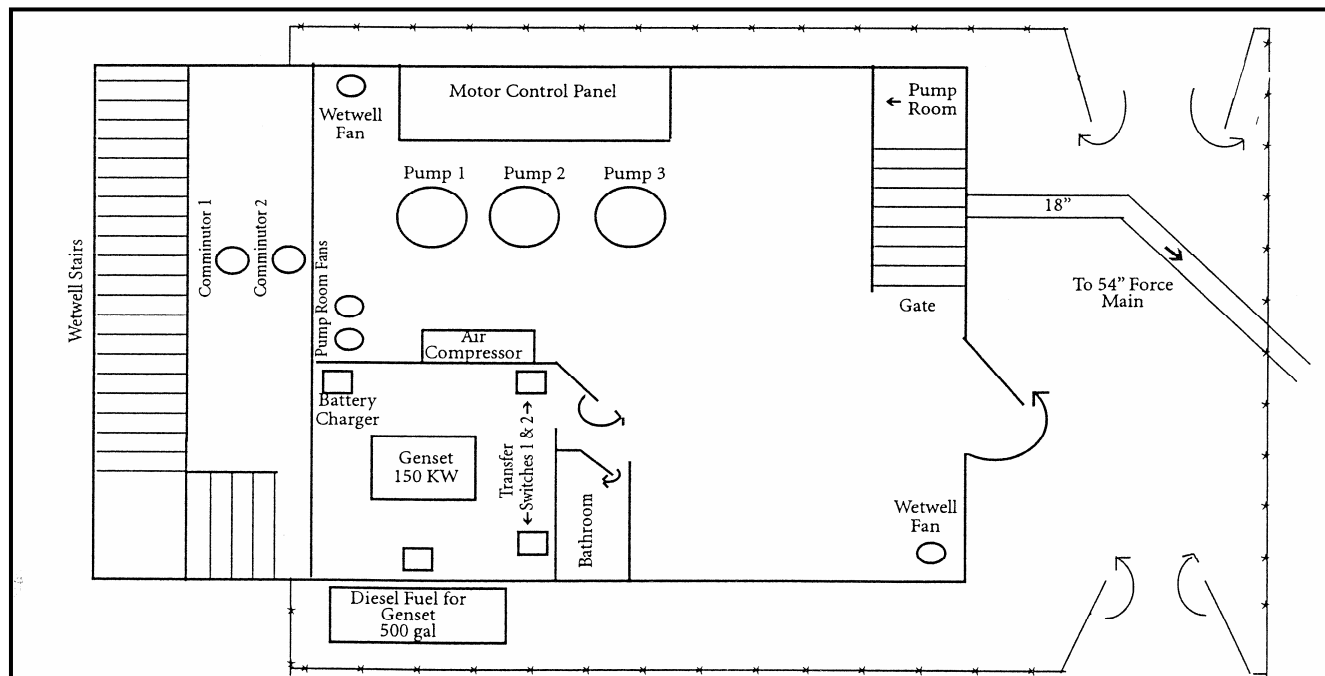
Field Visit Date	NA
PS Number & Name	11; San Quentin
Address	East Sir Francis Drake & West Gate
Year Constructed; Improvements Past/Future	1985; Mostly original other than repair/rebuilding.
Number of Pumps/Number of Standbys	2/1
Pump Type	3 electric dry-pit
Primary Power Source	PG&E, 480 V, 3-phase
Standby Generator	Diesel; 150 KW; 500 gal
Normal Operating Capacity (MGD)	2.88
Firm Capacity (MGD)	2.88
Operating Point (gpm/feet)	1400 gpm @ 53'
Influent Sewer Size/Effluent Force Main Size	8"/6"
Horsepower Rating (hp)/Motor Speed	30 hp
Pump Elevation (feet)	-5.79
Bypass capabilities	None
Notes	Pump station not inspected.
Identified Issues	NA
Recommendations	<ul style="list-style-type: none"> <li>• Piping &amp; Valving: NA</li> <li>• Electrical: NA</li> <li>• Instrumentation &amp; Control: NA</li> <li>• Structural: NA</li> <li>• Health &amp; Safety: NA</li> <li>• Neighborhood Nuisance: NA</li> <li>• Pumps Improvement: NA</li> <li>• Influent Sewer/Force Main: NA</li> <li>• Maintenance/Reliability: NA</li> <li>• Overflow Potential: NA</li> </ul>

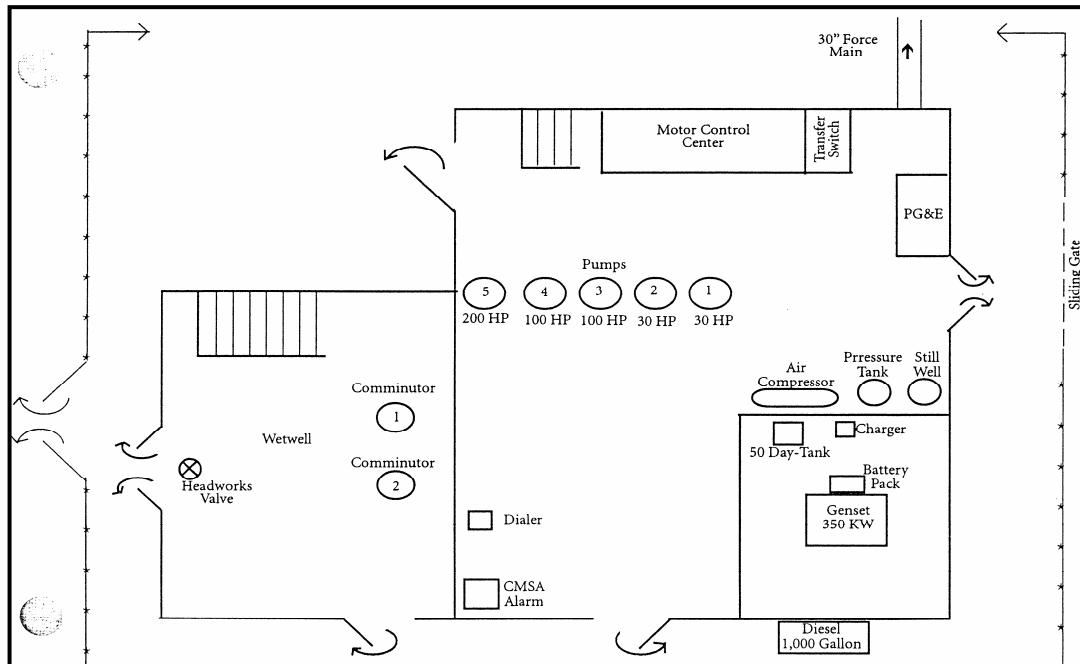
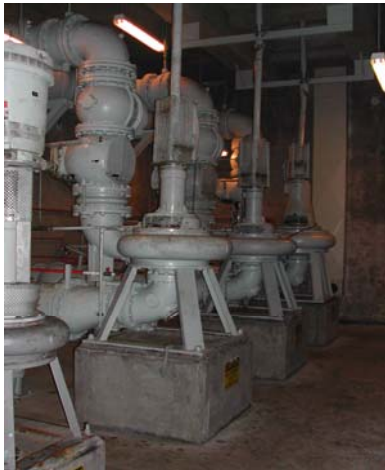
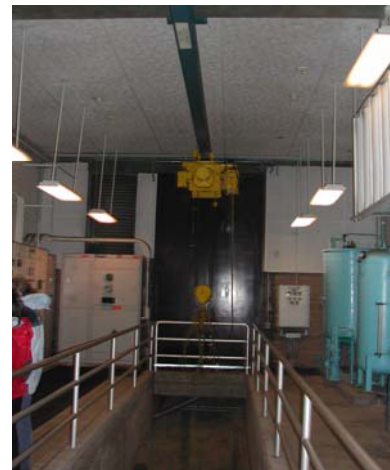
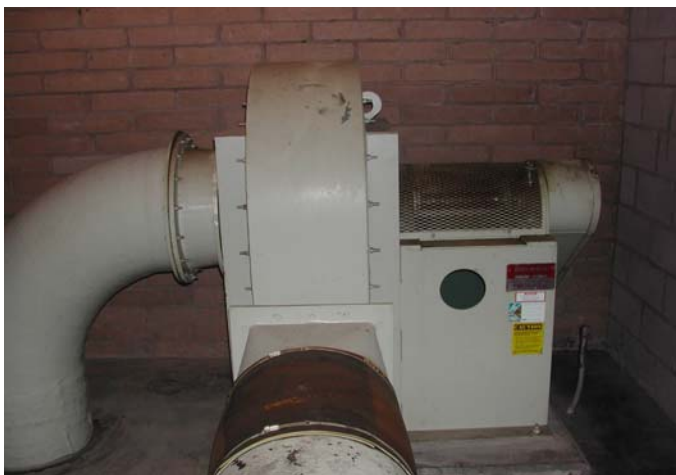
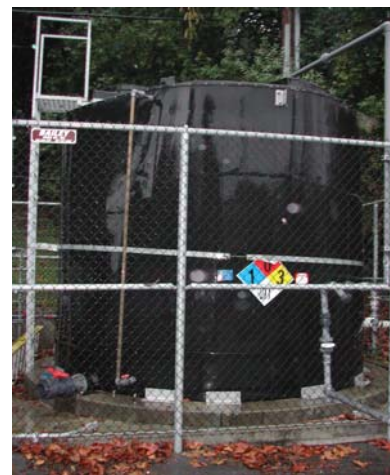
<b>Pump Elevation (feet)</b>	-15.96 (26.1 - 26.2) -15.31 (26.3 - 26.4) -14.92 (26.5)
<b>Bypass capabilities</b>	Dry weather bypass to PS 15. Bypass is untested.
<b>Notes</b>	<ul style="list-style-type: none"> <li>• Ultrasonic Oscillator flow meter.</li> <li>• Outage: Possible water leak identified on 6/21/2004.</li> </ul>
<b>Identified Issues</b>	<ul style="list-style-type: none"> <li>• PS 26.3 has a hole in check valve.</li> <li>• Ventilation: Forced air. Dual ventilation supply/exhaust. Exhaust fan is pushing more air in than pulling out.</li> <li>• Odor control: carbon-activated. Odor control fan to be checked for explosion-proofness. Rest of odor control room functions properly.</li> </ul>
<b>Recommendations</b>	<ul style="list-style-type: none"> <li>• <b>Piping &amp; Valving:</b> Replace valve downstream of flow meter.</li> <li>• <b>Electrical:</b> Allowance for general electrical upgrades.</li> <li>• <b>Instrumentation &amp; Control:</b> Install flow meter on the discharge line of each pump. Install bubbler. Connect to SCADA.</li> <li>• <b>Structural:</b> Allowance for general structural upgrades.</li> <li>• <b>Health &amp; Safety:</b> Improve ventilation to put building under negative pressure. Replace control odor fan, as needed.</li> <li>• <b>Neighborhood Nuisance:</b> NA</li> <li>• <b>Pumps Improvement:</b> NA</li> <li>• <b>Influent Sewer/Force Main:</b> NA</li> <li>• <b>Maintenance/Reliability:</b> NA</li> <li>• <b>Overflow Potential:</b> NA</li> </ul>

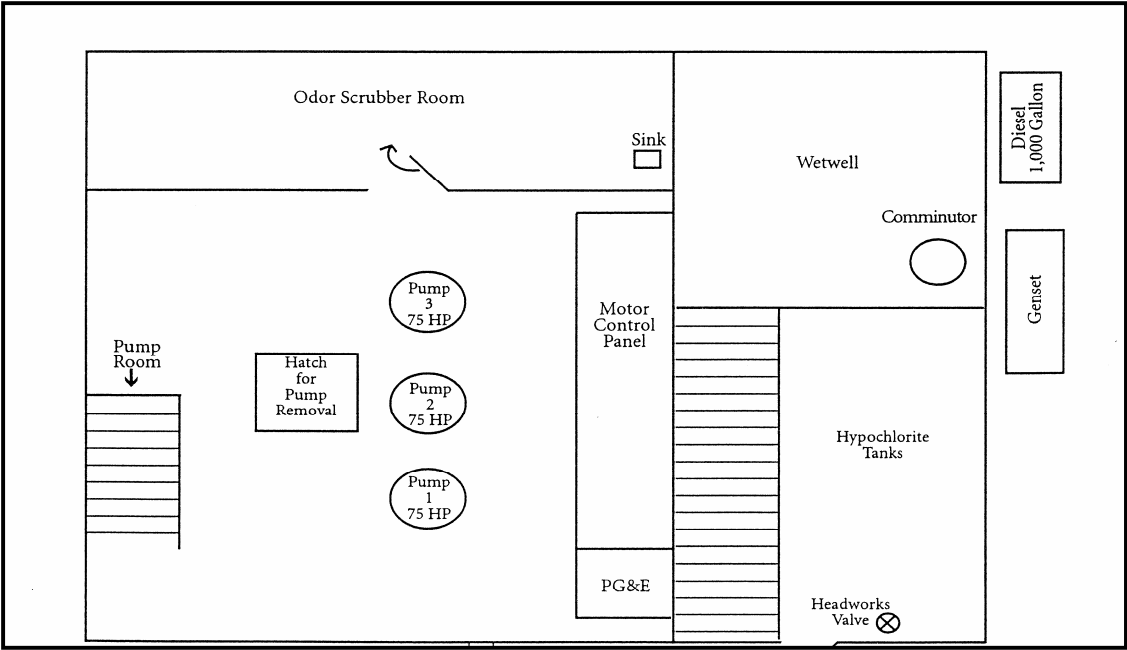
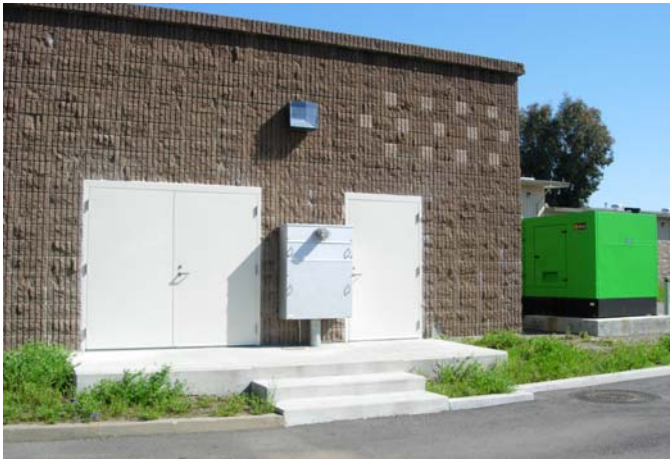
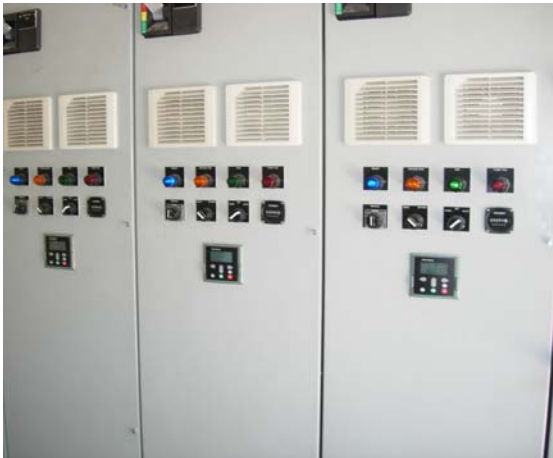
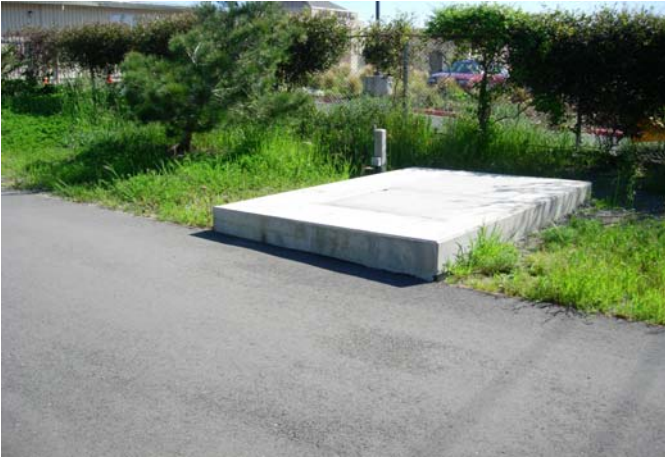
<b>Identified Issues</b>	<ul style="list-style-type: none"> <li>• Odor Control: An odor control room was installed at station to address odor problem (proximity to school).</li> <li>• Ventilation: There is only one vent in. A second vent could be installed for more air circulation.</li> <li>• Station is lacking firm capacity (See SHECAP results).</li> </ul>
<b>Recommendations</b>	<ul style="list-style-type: none"> <li>• <b>Piping &amp; Valving:</b> NA</li> <li>• <b>Electrical:</b> NA</li> <li>• <b>Instrumentation &amp; Control:</b> Install flow meter in existing flow meter vault. Install new control for new pumps, as needed. Connect flow meter to SCADA.</li> <li>• <b>Structural:</b> NA</li> <li>• <b>Health &amp; Safety:</b> Ventilation: Install one additional vent in.</li> <li>• <b>Neighborhood Nuisance:</b> NA</li> <li>• <b>Pumps Improvement:</b> Investigate whether the horsepower of motors or VFDs can increase the pump speed to reach design and firm capacity requirements. If this can't be accommodated, it may be needed to install 2 new pumps to address lack of firm capacity.</li> <li>• <b>Influent Sewer/Force Main:</b> NA</li> <li>• <b>Maintenance/Reliability:</b> NA</li> <li>• <b>Overflow Potential:</b> NA</li> </ul>

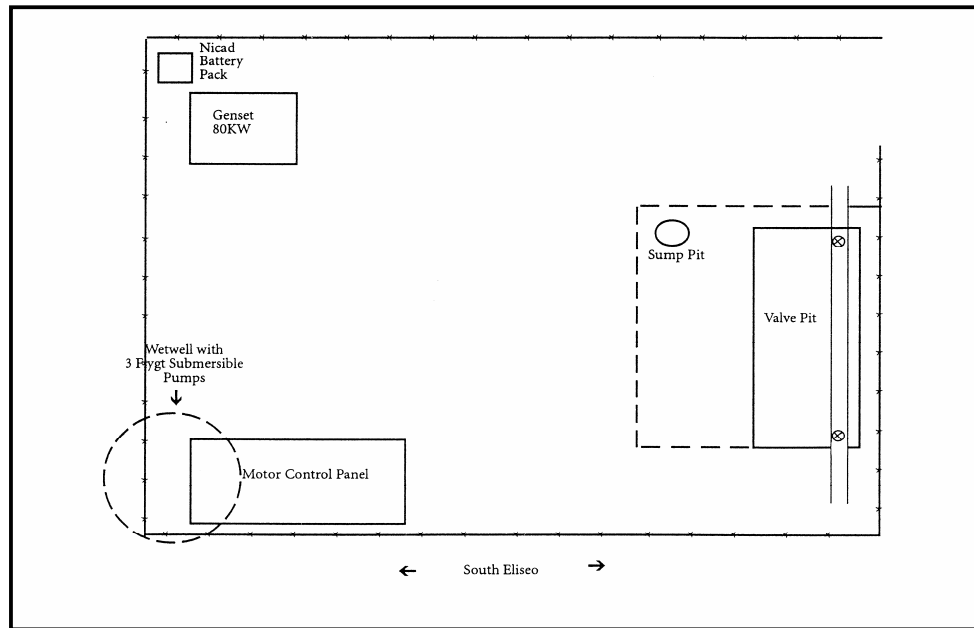
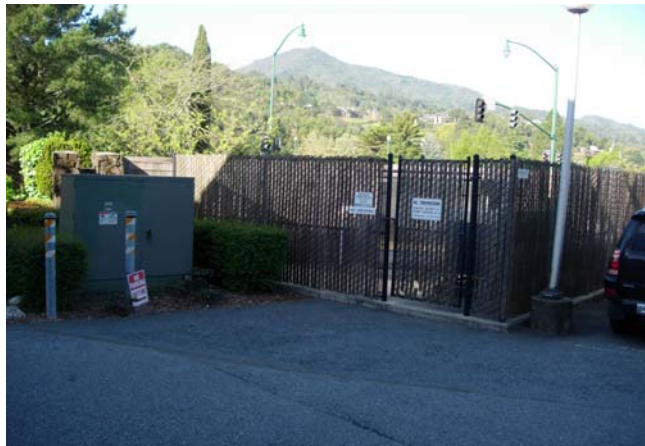
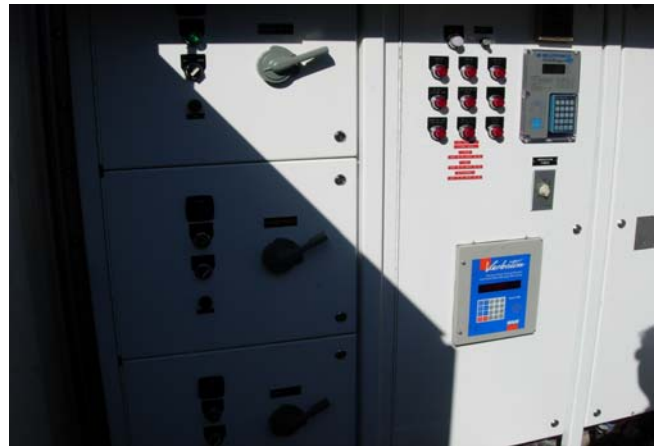
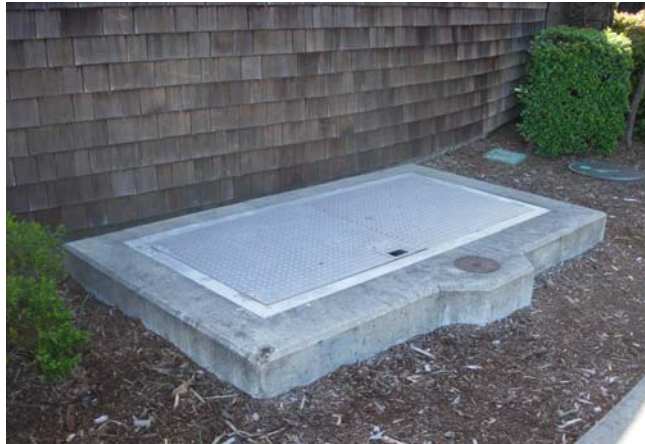
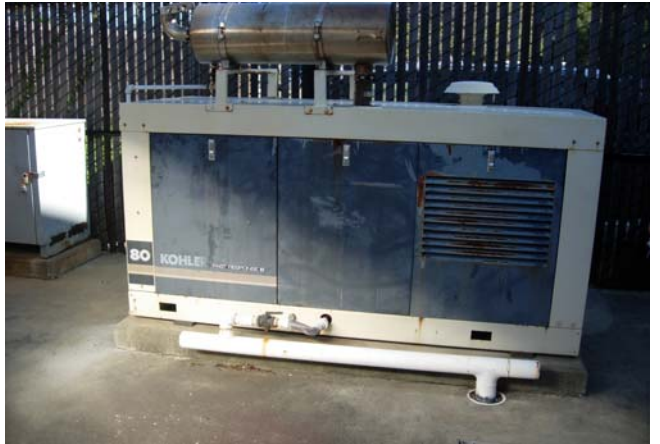
Identified Issues	<ul style="list-style-type: none"> <li>• Sound issue due to proximity to commercial development.</li> <li>• Traffic issue due to location of the pump at turning lane.</li> </ul>
Recommendations	<ul style="list-style-type: none"> <li>• <b>Piping &amp; Valving:</b> Construct flow meter vault.</li> <li>• <b>Electrical:</b> Install generator sound enclosure.</li> <li>• <b>Instrumentation &amp; Control:</b> Install flow meter. Install bubbler sensor. Connect to SCADA.</li> <li>• <b>Structural:</b> NA</li> <li>• <b>Health &amp; Safety:</b> NA</li> <li>• <b>Neighborhood Nuisance:</b> NA</li> <li>• <b>Pumps Improvement:</b> NA</li> <li>• <b>Influent Sewer/Force Main:</b> NA</li> <li>• <b>Maintenance/Reliability:</b> Improve station access.</li> <li>• <b>Overflow Potential:</b> NA</li> </ul>
