Ross Valley Sanitary District

General Manager's Monthly Bulletin

February 2025

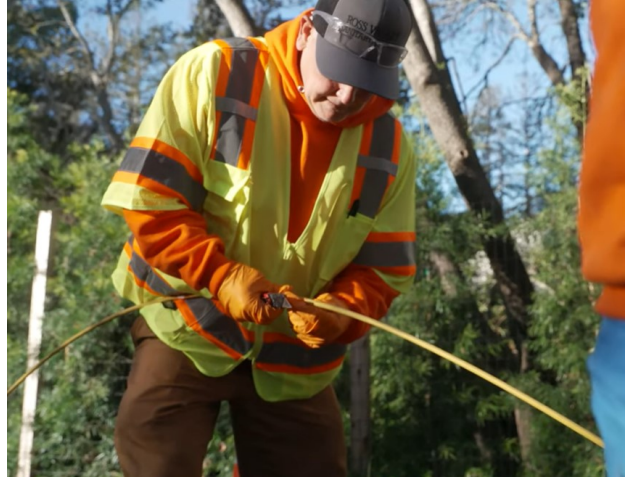
Staff completing point repair work

Our staff recently completed the installation of nineteen point repairs using the internal pipe patch repair system. This is a notable accomplishment, showcasing our ability to quickly and efficiently address critical issues within the RVSD collection system.

The majority of these repairs focused on "Grade 5" defects, which are categorized as "visible voids." These

defects are high priority because they pose significant risks to the system if not promptly addressed. They typically occur when a section of pipe deteriorates significantly, often due to age, corrosion, or external pressure. The pipe patch repair is about four-feet in length, and sometimes several can be installed on one pipe between two manholes.

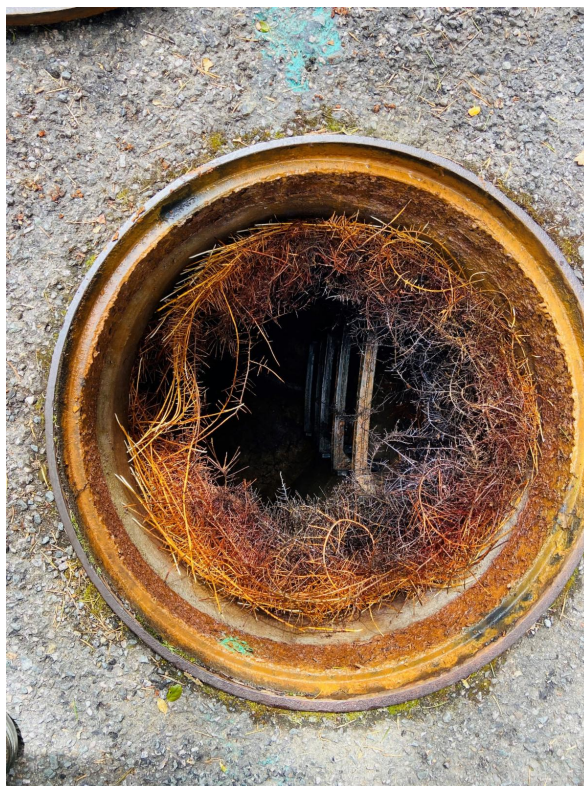
Roots invading a manhole

These vital rehabilitation efforts ensure a free-flowing system by addressing issues such as rough or misaligned channels, failing bases, and deteriorating rims and covers. In some cases, roots and debris infiltrate manholes and the surrounding pipes, as shown in the photo. Additionally, manhole rehabilitations are planned in the wet season because higher groundwater levels reveal the locations where grouting can stop infiltration and inflow. If left unaddressed, these problems can lead to blockages and even spills. Additionally, misaligned rims and covers can create unwanted noise for nearby residents.

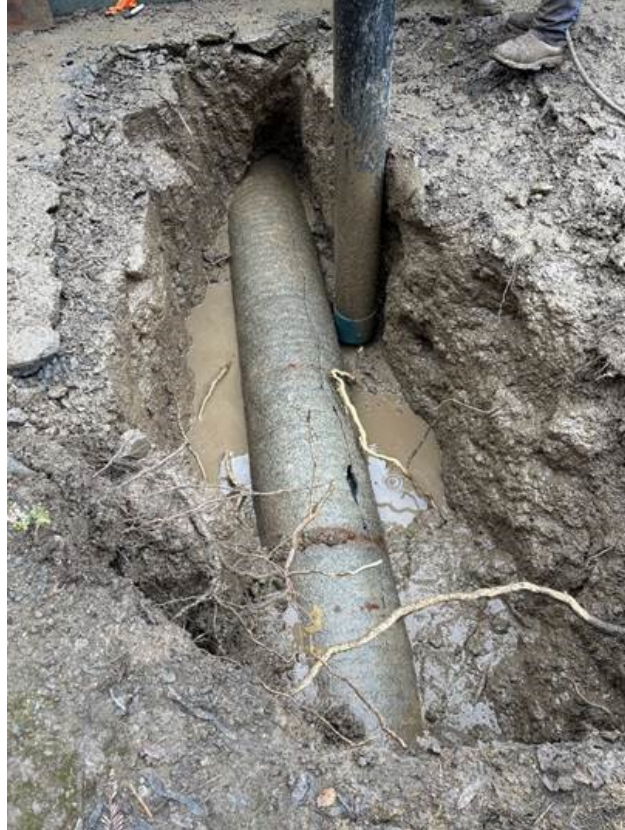
FM14 pipe defects at location of leak

After the storms passed, staff carefully excavated the area of the leak, using hydroexcavation techniques with our Vaccon combination (vacuum-jetter) truck to preserve the pipe. We discovered that there were two parallel fourteen-foot-long cracks along the top of the pipe, and one hole along one of the cracks where the wastewater spilled out. An abandoned fence post with a large concrete plug had been poured directly onto the force main. The force main is only 31 inches below ground surface at the spill site, more shallow than expected. A concrete slab and shipping container were directly on top of this posthole concrete, focusing weight like a spike directly on the pipe.

The CCTV inspection revealed the cause of the spill and provided valuable insight into the pipe's condition. We

discovered an unknown “high point” of elevation in this force main at the spill location where corrosive hydrogen sulfide gas was allowed to accumulate for decades. The corrosive gas compromised the structural integrity of the pipe, erasing the cementitious layer and eroding the steel cylinder. We measured about 70 linear feet of corroded pipe crown in this area, and about 28 feet of severely corroded pipe around the spill location where the metal layer flaked away to the reinforced concrete outer layer.

In force main design and construction, air release valves are installed at such high points to prevent accumulation of gas pockets that cause such corrosion impacts and to maintain the flow capacity of the force mains. The installation of this key asset may have been overlooked all those years ago, with the omission finally catching up with the District sixty years later. An alternative theory is that soils differentially settled creating a localized high point on a formerly flat sewer. The posthole concrete and concentrated weight on the pipe may have been a contributing factor, but the cause of this spill was pipe corrosion caused by the lack of air release at a force main high point.

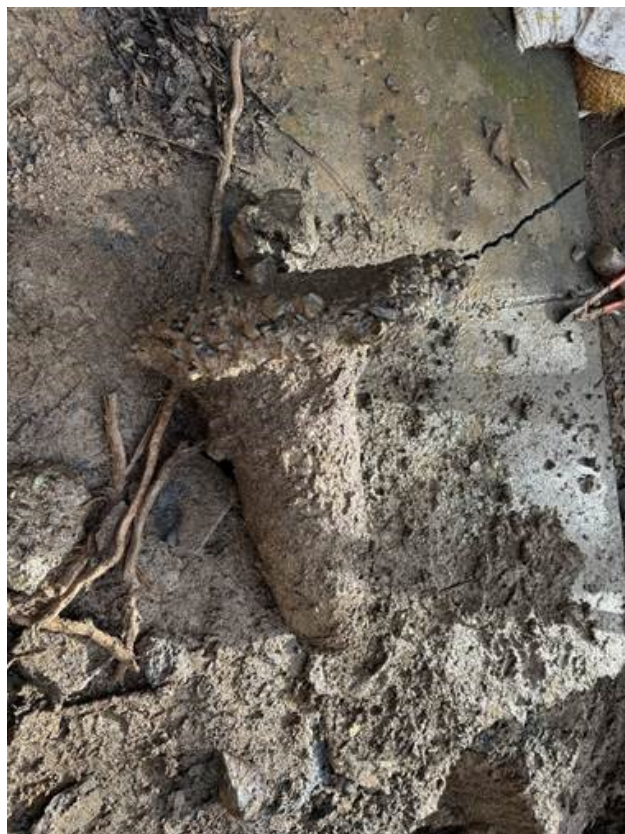
Fence posthole concrete that was poured directly onto the FM14 pipe where it spilled

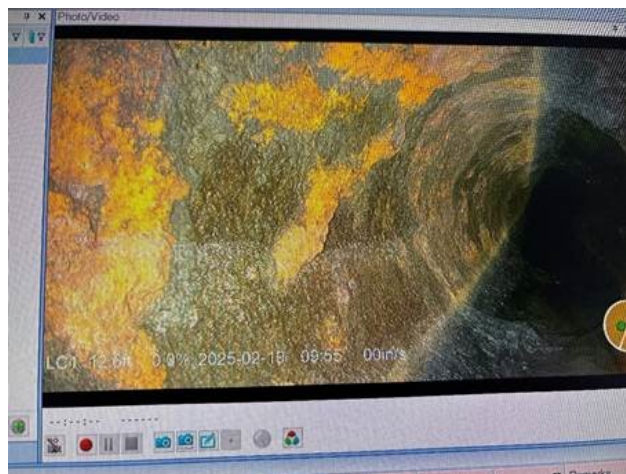
Corroded steel on crown of FM14, twelve feet upstream of leak location

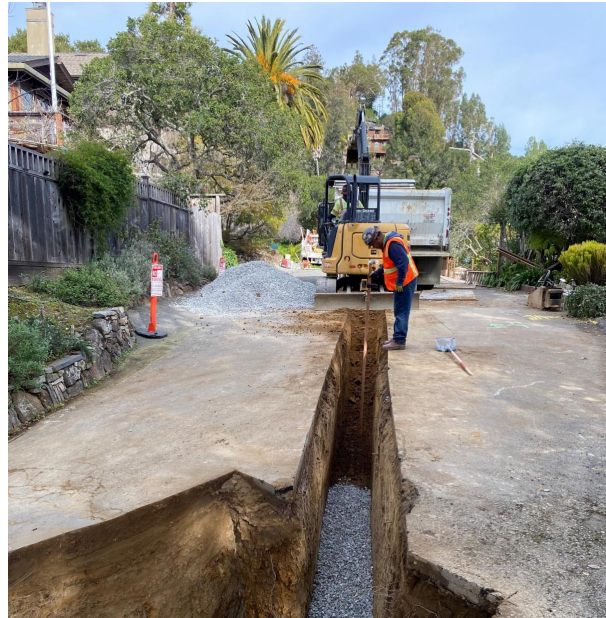
Open-cut installation

This project will replace approximately 2.8 miles (14,042 linear feet) of aging gravity sewer pipelines in San Anselmo, Fairfax, and Kentfield. Work will involve open-cut removal, pipe bursting, and reaming, as well as the installation of new high-density polyethylene (HDPE) pipe and 33 sewer manholes. The project is expected to improve sewer infrastructure and address critical maintenance needs in high-risk areas. Notably, the awarded bid came in 26% below the engineer's estimate, making it a cost-effective solution for our community.
