**Ross Valley Sanitary District**

**Sewer System Replacement Master**

**Draft Final Report**

**January 2007**

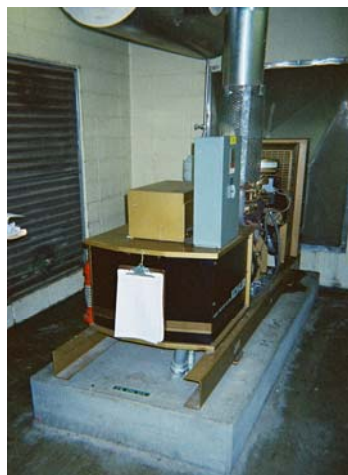
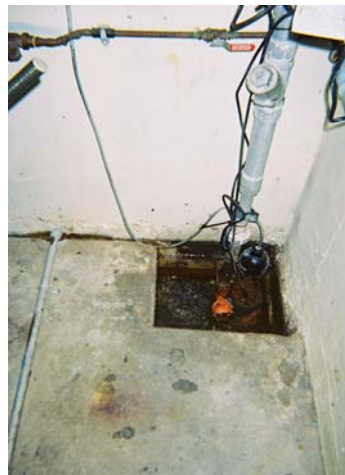
Field Visit Date	12/1/2005
PS Number & Name	12; Bon Air Center PS
Address	380 Bon Air Shopping Center Sir Francis Drake Blvd & Eliseo Drive, Greenbrae
Year Constructed; Improvements Past/Future	1984; Mostly original other than repair/rebuilding.
Number of Pumps/Number of Standbys	1/1
Pump Type	Dry-pit; two-speed pump
Primary Power Source	PG&E, 220 V
Standby Generator	Natural gas generator; 60 KW
Normal Operating Capacity (MGD)	1.51
Firm Capacity (MGD)	0.68
Operating Point (gpm/feet)	300 gpm @43'
Influent Sewer Size/Effluent Force Main Size	6"/4"
Horsepower Rating (hp)/Motor Speed	15 hp @ 1780 rpm//6.7 hp @ 1185 rpm
Pump Elevation (feet)	-10.5
Bypass capabilities	None
Notes	<ul style="list-style-type: none"> <li>• Alarm: station is controlled with bubbler.</li> <li>• Outage: Pump station failed on 8/25/2003.</li> </ul>
Identified Issues	<ul style="list-style-type: none"> <li>• Air release valve does not work well.</li> <li>• Suction head problems probably resulting from vacuum on suction line. Bigger suction line to be installed to fix head problems.</li> <li>• Comminutor is not brought back on-line after power outage.</li> <li>• Ventilation: Vent into station is not activated because it pumps air from the wet well and needs to be fixed. No air mechanism other than grate opening to take air out.</li> <li>• Existing odor problem; odor control may be needed in the future, due to the location of the station.</li> <li>• During high flow conditions, 2 pumps are needed to convey peak flows. There is</li> </ul>

Recommendations	<ul style="list-style-type: none"> <li>• <b>Piping &amp; Valving:</b> Replace pump suction line. Repair air release valve.</li> <li>• <b>Electrical:</b> Allowance for general electrical upgrades.</li> <li>• <b>Instrumentation &amp; Control:</b> Install flow meter. Fix pump control. Connect to SCADA.</li> <li>• <b>Structural:</b> Allowance for general structural upgrades.</li> <li>• <b>Health &amp; Safety:</b> Install adequate ventilation system.</li> <li>• <b>Neighborhood Nuisance:</b> Install odor control system.</li> <li>• <b>Pumps Improvement:</b> Increase firm capacity of station by replacing the 2 pumps.</li> <li>• <b>Influent Sewer/Force Main:</b> NA</li> <li>• <b>Maintenance/Reliability:</b> NA</li> <li>• <b>Overflow Potential:</b> NA</li> </ul>

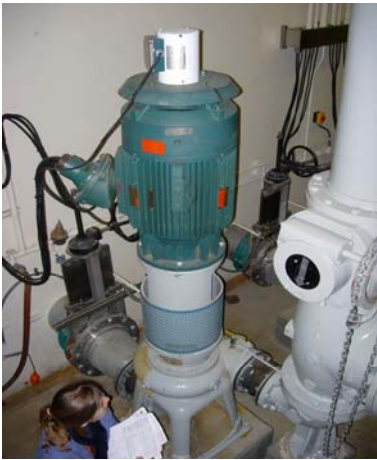
<b>Field Visit Date</b>	19-Apr-06
<b>PS Number &amp; Name</b>	14; Larkspur Main PS
<b>Address</b>	200 Doherty Drive
<b>Year Constructed; Improvements Past/Future</b>	1989; Motors/Rail/Electrical panels rehabilitated in 2005.
<b>Number of Pumps/Number of Standbys</b>	1/1/1 (Lead/Lag/Standby)
<b>Pump Type</b>	Variable speed electric (Lead/Lag); standby is operated at constant speed.
<b>Primary Power Source</b>	PG&E, 480V, 3-phase
<b>Standby Generator</b>	Diesel backup generator; 350 KW; 50 gal
<b>Normal Operating Capacity (MGD)</b>	8.4
<b>Firm Capacity (MGD)</b>	5.9
<b>Operating Point (gpm/feet)</b>	1200 gpm @ 95' (pumps 1 & 2 to PS 13) 1200 gpm @ 122' (pump 3 to 42-inch pipeline)
<b>Influent Sewer Size/Effluent Force Main Size</b>	5"/ 8"/6"
<b>Horsepower Rating (hp)/Motor Speed (rpm)</b>	75 hp @ 1780 rpm
<b>Pump Elevation (feet)</b>	-8.57
<b>Bypass capabilities</b>	Wet weather bypass to PS 13.
<b>Notes</b>	<ul style="list-style-type: none"> <li>• Pump station is on data loggers and cell phone since December 31, 2005 flood.</li> <li>• Motors are immersible.</li> <li>• Flow monitoring: There is a flow meter vault installed outside of the pump building but no flow meter has been installed yet.</li> </ul>

<b>Identified Issues</b>	<ul style="list-style-type: none"> <li>• Odor Control: An odor control room was installed at station to address odor problem (proximity to school).</li> <li>• Ventilation: There is only one vent in. A second vent could be installed for more air circulation.</li> <li>• Station is lacking firm capacity (See SHECAP results).</li> </ul>
<b>Recommendations</b>	<ul style="list-style-type: none"> <li>• <b>Piping &amp; Valving:</b> NA</li> <li>• <b>Electrical:</b> NA</li> <li>• <b>Instrumentation &amp; Control:</b> Install flow meter in existing flow meter vault. Install new control for new pumps, as needed. Connect flow meter to SCADA.</li> <li>• <b>Structural:</b> NA</li> <li>• <b>Health &amp; Safety:</b> Ventilation: Install one additional vent in.</li> <li>• <b>Neighborhood Nuisance:</b> NA</li> <li>• <b>Pumps Improvement:</b> Investigate whether the horsepower of motors or VFDs can increase the pump speed to reach design and firm capacity requirements. If this can't be accommodated, it may be needed to install 2 new pumps to address lack of firm capacity.</li> <li>• <b>Influent Sewer/Force Main:</b> NA</li> <li>• <b>Maintenance/Reliability:</b> NA</li> <li>• <b>Overflow Potential:</b> NA</li> </ul>

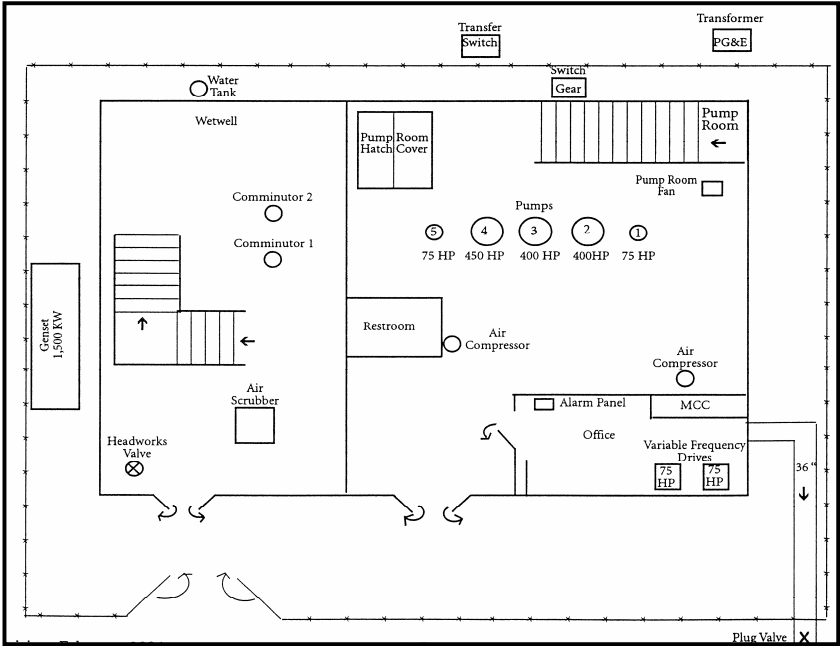
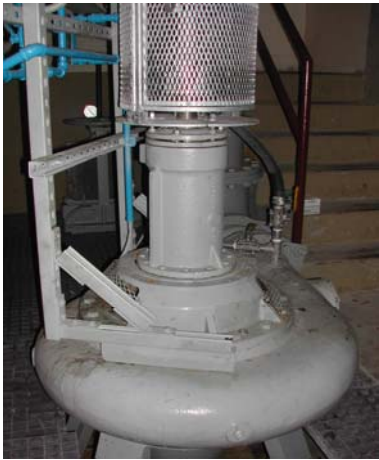
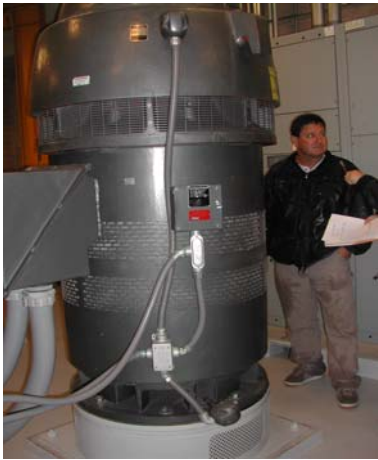
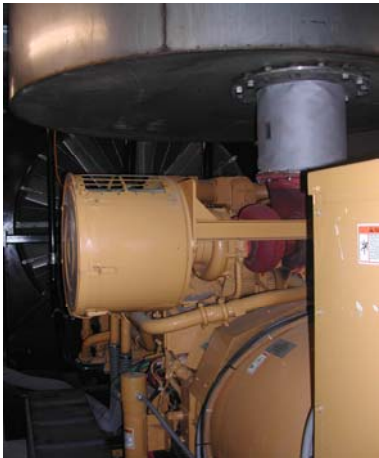
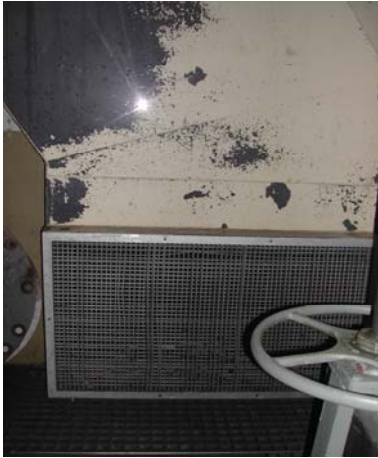
<b>Field Visit Date</b>	12/1/2005
<b>PS Number &amp; Name</b>	15; Kentfield PS
<b>Address</b>	Corte Madera Creek & Stadium Way, Kentfield
<b>Year Constructed; Improvements Past/Future</b>	1971 (original); rehabilitated in 2005; All PS have been rehabilitated recently.
<b>Number of Pumps/Number of Standbys</b>	Pumps 1 & 5 (Dry weather) Pumps 2, 3 & 4 (Wet weather)
<b>Pump Type</b>	Dry-pit, variable speed.
<b>Primary Power Source</b>	PG&E
<b>Standby Generator</b>	Diesel backup generator; 6000 gal; 1,500 KW
<b>Normal Operating Capacity (MGD)</b>	41.9
<b>Firm Capacity (MGD)</b>	36.9
<b>Operating Point (gpm/feet)</b>	4000 gpm @ 56' (Pumps 1 & 5) 16,000 gpm @ 78' (Pumps 2, 3 & 4)
<b>Influent Sewer Size/Effluent Force Main Size</b>	20"/24" (pumps 2, 3 & 4)
<b>Horsepower Rating (hp)/Motor Speed (rpm)</b>	75 hp @ 750 rpm (Pumps 1 & 5) 400 hp @ 895 rpm (Pumps 2, 3 & 4)
<b>Pump Elevation (feet)</b>	-16/-14
<b>Bypass capabilities</b>	Dry-weather bypass to PS 13.

<b>Notes</b>	<ul style="list-style-type: none"> <li>• Insulator between SS header and support.</li> <li>• Pneumatic valves on discharge.</li> <li>• Air tank move water fail safe.</li> <li>• Outage: Various issues, especially in late 2003. Outage in December 2005.</li> </ul>
<b>Identified Issues</b>	<ul style="list-style-type: none"> <li>• Ventilation: Air comes in only one side of station.</li> <li>• Station is lacking firm capacity based on SHECAP analysis.</li> <li>• There is only 1 flow meter for 5 pumps.</li> </ul>
<b>Recommendations</b>	<ul style="list-style-type: none"> <li>• <b>Piping &amp; Valving:</b> NA</li> <li>• <b>Electrical:</b> Electrical allowance if VFDs need to be replaced.</li> <li>• <b>Instrumentation &amp; Control:</b> Install flow meters at discharge end of each pump. Install new control for new pumps, as needed. Connect to SCADA.</li> <li>• <b>Structural:</b> NA</li> <li>• <b>Health &amp; Safety:</b> Improve ventilation system.</li> <li>• <b>Neighborhood Nuisance:</b> NA</li> <li>• <b>Pumps Improvement:</b> Firm capacity is likely to be addressed by rehabilitating and upsizing the existing 36" force main to 42" (See Force Main Master Plan). If problem persists after force main size increase, increase the size of 2 dry-weather pumps (possibly by increasing pumps speed, provided motors or VFDs have adequate capacity; otherwise, VFDs would have to be replaced).</li> <li>• <b>Influent Sewer/Force Main:</b> NA</li> <li>• <b>Maintenance/Reliability:</b> NA</li> <li>• <b>Overflow Potential:</b> NA</li> </ul>

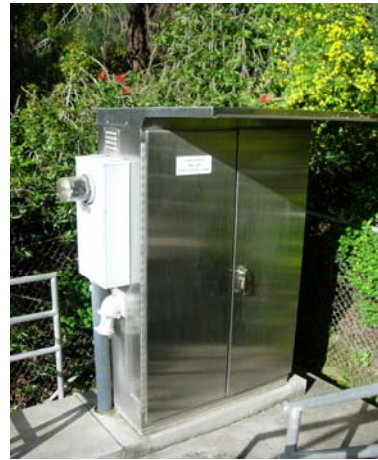
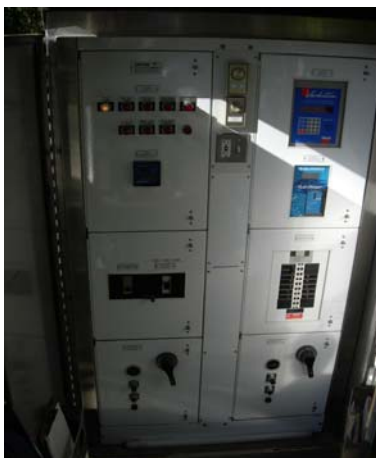
<b>Field Visit Date</b>	4/19/2006
<b>PS Number &amp; Name</b>	21; 101
<b>Address</b>	Highway 101 & Corte Placida, Greenbrae
<b>Year Constructed; Improvements Past/Future</b>	Mid-1040s; 2000
<b>Number of Pumps/Number of Standbys</b>	1/1
<b>Pump Type</b>	Submersible
<b>Primary Power Source</b>	PG&E
<b>Standby Generator</b>	Portable diesel; 60 KW; 125 gal
<b>Normal Operating Capacity (MGD)</b>	Unknown (Assumed 0.22 MGD)
<b>Firm Capacity (MGD)</b>	Unknown (Assumed 0.22 MGD)
<b>Operating Point (gpm/feet)</b>	150 gpm
<b>Influent Sewer Size/Effluent Force Main Size</b>	6"/4" to pumps to MH#B-230.07
<b>Horsepower Rating (hp)/Motor Speed</b>	23 hp
<b>Pump Elevation (feet)</b>	Unknown
<b>Bypass capabilities</b>	None
<b>Notes</b>	<ul style="list-style-type: none"> <li>• Ultrasonic level in wet well.</li> </ul>
<b>Identified Issues</b>	<ul style="list-style-type: none"> <li>• Original ductile iron force main needs to be replaced (see Force Main Master Plan).</li> <li>• Limited access to station from Highway 101.</li> </ul>

<b>Recommendations</b>	<ul style="list-style-type: none"> <li>• <b>Piping &amp; Valving:</b> Construct flow meter vault.</li> <li>• <b>Electrical:</b> NA</li> <li>• <b>Instrumentation &amp; Control:</b> Install flow meter. Install bubbler sensor. Connect to SCADA.</li> <li>• <b>Structural:</b> NA</li> <li>• <b>Health &amp; Safety:</b> NA</li> <li>• <b>Neighborhood Nuisance:</b> NA</li> <li>• <b>Pumps Improvement:</b> NA</li> <li>• <b>Influent Sewer/Force Main:</b> Evaluate possibility to raise the manhole to increase wet well volume and delay overflow. Replace force main.</li> <li>• <b>Maintenance/Reliability:</b> NA</li> <li>• <b>Overflow Potential:</b> NA</li> <li>• <b>Redundancy:</b> Evaluate possibility of eliminating pump station by boring &amp; jacking below HWY 101 and connecting to gravity sewer discharging to PS 20.</li> </ul>

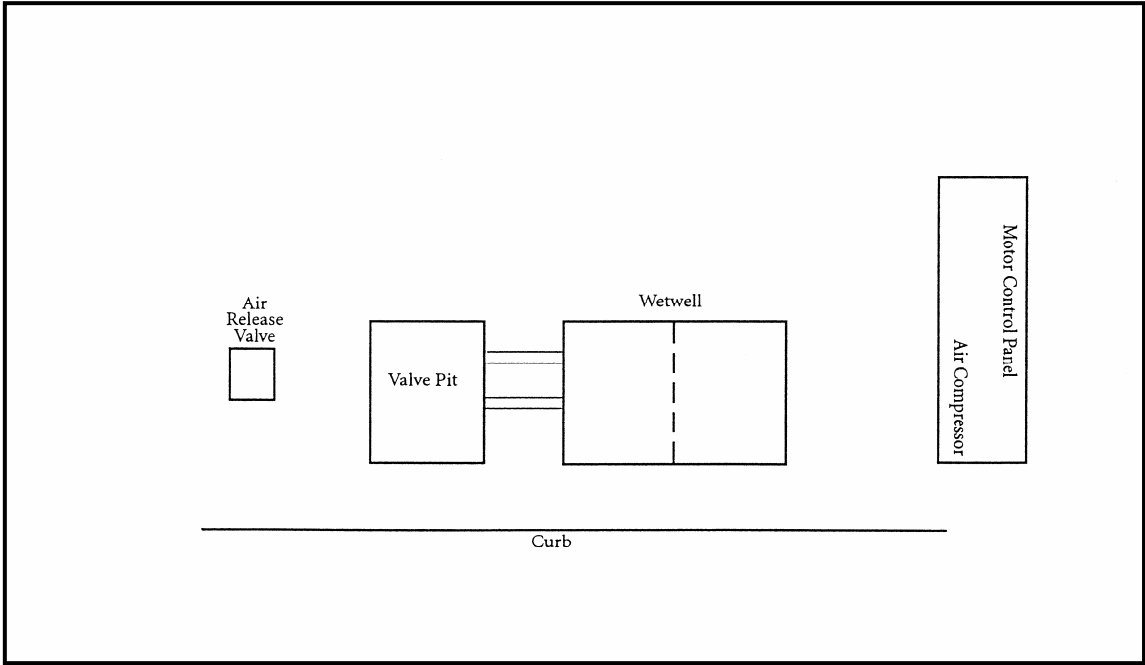
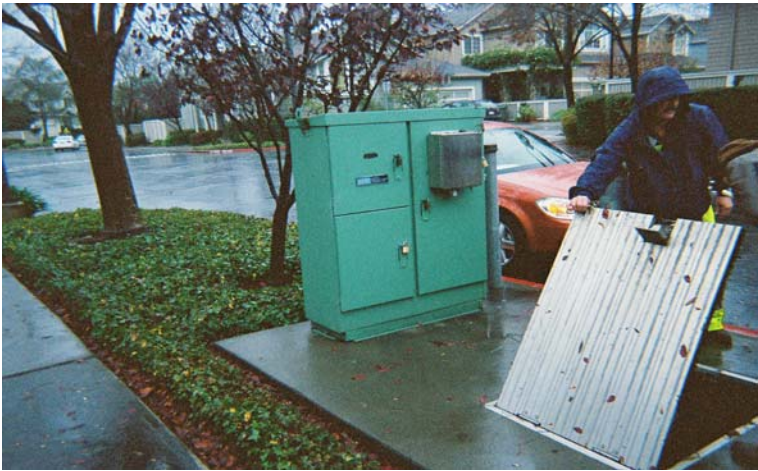
<b>Field Visit Date</b>	12/1/2005
<b>PS Number &amp; Name</b>	22; Cape Marin
<b>Address</b>	2 Scott Place
<b>Year Constructed; Improvements Past/Future</b>	Late 1990s (Mostly original other than repair/rebuilding)
<b>Number of Pumps/Number of Standbys</b>	1/1
<b>Pump Type</b>	Submersible
<b>Primary Power Source</b>	PG&E
<b>Standby Generator</b>	Portable diesel; 60 KW; 125 gal
<b>Normal Operating Capacity (MGD)</b>	Unknown (Assumed 0.22 MGD)
<b>Firm Capacity (MGD)</b>	Unknown (Assumed 0.22 MGD)
<b>Operating Point (gpm/feet)</b>	150 gpm
<b>Influent Sewer Size/Effluent Force Main Size</b>	6"/6"
<b>Horsepower Rating (hp)/Motor Speed (rpm)</b>	5 hp
<b>Pump Elevation (feet)</b>	Unknown
<b>Bypass capabilities</b>	None
<b>Notes</b>	<ul style="list-style-type: none"> <li>• Station cleaning occurs 1 to 2 times per year.</li> <li>• Outage: Power failures on 4/7/2000 and due to heavy rain on 11/8/2002. Water in pump #1 on 3/27/2000.</li> </ul>

<b>Identified Issues</b>	<ul style="list-style-type: none"> <li>• None</li> </ul>
<b>Recommendations</b>	<ul style="list-style-type: none"> <li>• <b>Piping &amp; Valving:</b> Construct flow meter vault.</li> <li>• <b>Electrical:</b> NA</li> <li>• <b>Instrumentation &amp; Control:</b> Install flow meter. Connect to SCADA.</li> <li>• <b>Structural:</b> NA</li> <li>• <b>Health &amp; Safety:</b> NA</li> <li>• <b>Neighborhood Nuisance:</b> NA</li> <li>• <b>Pumps Improvement:</b> NA</li> <li>• <b>Influent Sewer/Force Main:</b> NA</li> <li>• <b>Maintenance/Reliability:</b> NA</li> <li>• <b>Overflow Potential:</b> NA</li> <li>• <b>Redundancy:</b> Evaluate possibility of eliminating pump station or Capurro pump station (PS 23) (both stations are in the same vicinity).</li> </ul>

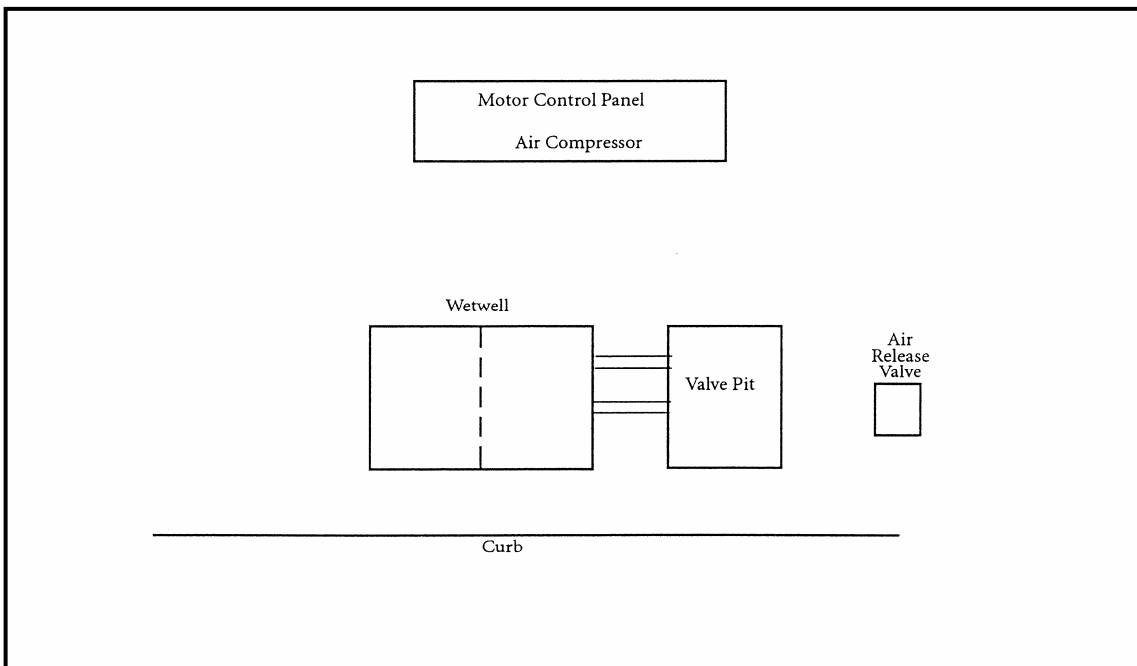
Field Visit Date	4/19/2006
PS Number & Name	23; Capurro
Address	48 Elizabeth
Year Constructed; Improvements Past/Future	Late 1990s
Number of Pumps/Number of Standbys	1/1
Pump Type	Submersible
Primary Power Source	PG&E
Standby Generator	Portable diesel; 60 KW; 125 gal
Normal Operating Capacity (MGD)	Unknown (Assumed 0.22 MGD)
Firm Capacity (MGD)	Unknown (Assumed 0.22 MGD)
Operating Point (gpm/feet)	150 gpm
Influent Sewer Size/Effluent Force Main Size	8"/6"
Horsepower Rating (hp)/Motor Speed (rpm)	5 hp
Pump Elevation (feet)	Unknown
Bypass capabilities	None
Notes	<ul style="list-style-type: none"> <li>• Station cleaning occurs 1 to 2 times per year.</li> </ul>
Identified Issues	<ul style="list-style-type: none"> <li>• None</li> </ul>
Recommendations	<ul style="list-style-type: none"> <li>• <b>Piping &amp; Valving:</b> Construct flow meter vault.</li> <li>• <b>Electrical:</b> NA</li> <li>• <b>Instrumentation &amp; Control:</b> Install flow meter. Connect to SCADA.</li> <li>• <b>Structural:</b> NA</li> <li>• <b>Health &amp; Safety:</b> NA</li> <li>• <b>Neighborhood Nuisance:</b> NA</li> <li>• <b>Pumps Improvement:</b> NA</li> <li>• <b>Influent Sewer/Force Main:</b> NA</li> <li>• <b>Maintenance/Reliability:</b> NA</li> <li>• <b>Overflow Potential:</b> NA</li> <li>• <b>Redundancy:</b> Evaluate possibility of eliminating pump station or Capurro pump station (PS 23) (both stations are in the same vicinity).</li> </ul>

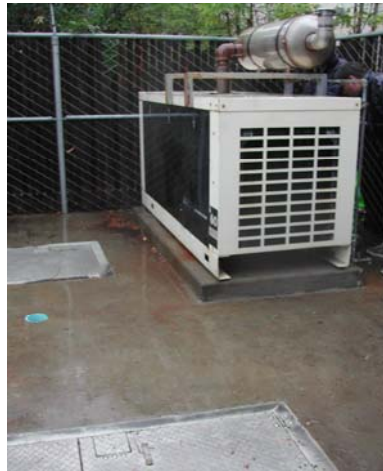
<b>Field Visit Date</b>	12/1/2005
<b>PS Number &amp; Name</b>	24; So. Eliseo Tennis Court PS
<b>Address</b>	630 South Eliseo Drive & Via Holon, Larskpur
<b>Year Constructed; Improvements Past/Future</b>	1984; Mostly original other than repair/rebuilding.
<b>Number of Pumps/Number of Standbys</b>	1/1
<b>Pump Type</b>	Submersible
<b>Primary Power Source</b>	PG&E
<b>Standby Generator</b>	Natural gas; 60 KW
<b>Normal Operating Capacity (MGD)</b>	1.52
<b>Firm Capacity (MGD)</b>	1.52
<b>Operating Point (gpm/feet)</b>	500 gpm @ 86'
<b>Influent Sewer Size/Effluent Force Main Size</b>	12"/10"
<b>Horsepower Rating (hp)/Motor Speed (rpm)</b>	20 hp
<b>Pump Elevation (feet)</b>	-5.4
<b>Bypass capabilities</b>	Bypass to Grenbrae PS 13. Open 8" line to PS 13 and close 10" line to 36" Force main.
<b>Notes</b>	<ul style="list-style-type: none"> <li>• Outage: Power failure due to heavy rain on 11/8/2002.</li> </ul>
<b>Identified Issues</b>	<ul style="list-style-type: none"> <li>• Sound issue due to proximity to residential housing.</li> </ul>

<b>Recommendations</b>	<ul style="list-style-type: none"> <li>• <b>Piping &amp; Valving:</b> Construct flow meter vault.</li> <li>• <b>Electrical:</b> Install generator sound enclosure.</li> <li>• <b>Instrumentation &amp; Control:</b> Install flow meter. Connect to SCADA.</li> <li>• <b>Structural:</b> NA</li> <li>• <b>Health &amp; Safety:</b> NA</li> <li>• <b>Neighborhood Nuisance:</b> NA</li> <li>• <b>Pumps Improvement:</b> NA</li> <li>• <b>Influent Sewer/Force Main:</b> NA</li> <li>• <b>Maintenance/Reliability:</b> NA</li> <li>• <b>Overflow Potential:</b> NA</li> </ul>

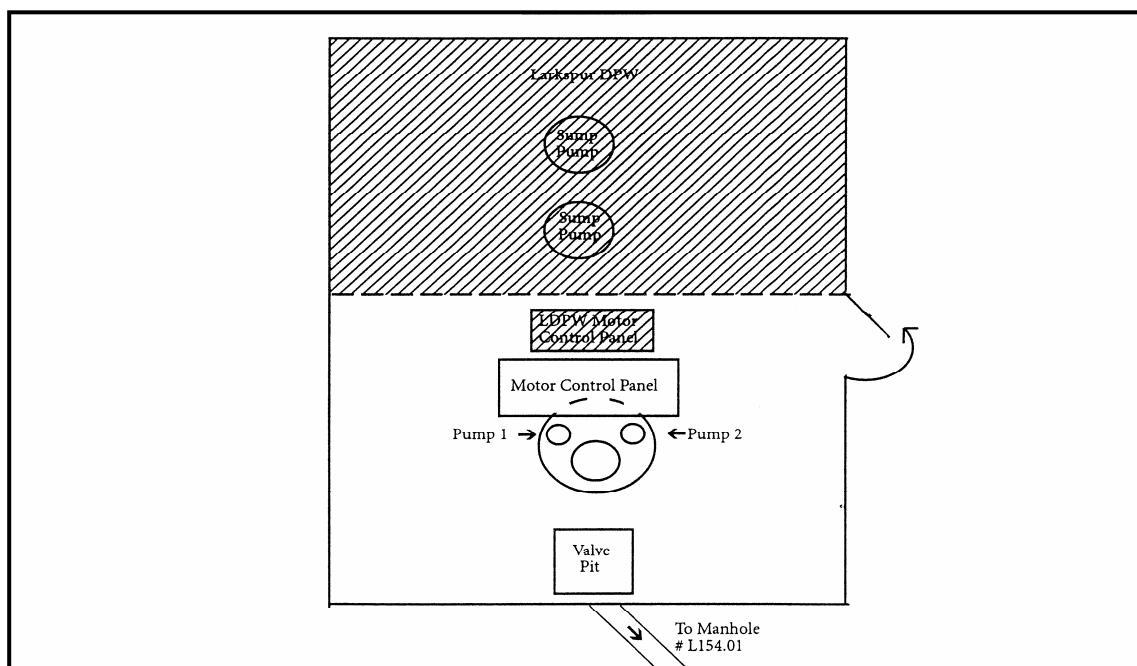
Field Visit Date	NA
PS Number & Name	30; Heather Garden
Address	92 Diane Lane, Larkspur
Year Constructed; Improvements Past/Future	-
Number of Pumps/Number of Standbys	1/1
Pump Type	Submersible
Primary Power Source	PG&E
Standby Generator	Diesel generator (maintained by Larkspur DPW)
Normal Operating Capacity (MGD)	Unknown (Assumed 0.22 MGD)
Firm Capacity (MGD)	Unknown (Assumed 0.22 MGD)
Operating Point (gpm/feet)	150 gpm
Influent Sewer Size/Effluent Force Main Size	8"/6"
Horsepower Rating (hp)/Motor Speed (rpm)	2.3 hp
Pump Elevation (feet)	Unknown
Bypass capabilities	None
Notes	<ul style="list-style-type: none"> <li>Sewers are surcharged. May require pump station upsizing if sewers surcharging is addressed.</li> </ul>
Identified Issues	<ul style="list-style-type: none"> <li>Surcharging mains during wet-weather flows.</li> </ul>
Recommendations	<ul style="list-style-type: none"> <li><b>Piping &amp; Valving:</b> Construct flow meter vault; Replace piping and valving as needed.</li> <li><b>Electrical:</b> NA</li> <li><b>Instrumentation &amp; Control:</b> Install flow meter. Install controls for new pumps, as needed. Connect to SCADA.</li> <li><b>Structural:</b> General structural modifications.</li> <li><b>Health &amp; Safety:</b> NA</li> <li><b>Neighborhood Nuisance:</b> NA</li> <li><b>Pumps Improvement:</b> Replace pumps to alleviate surcharging problems.</li> <li><b>Influent Sewer/Force Main:</b> NA</li> <li><b>Maintenance/Reliability:</b> NA</li> <li><b>Overflow Potential:</b> NA</li> </ul>

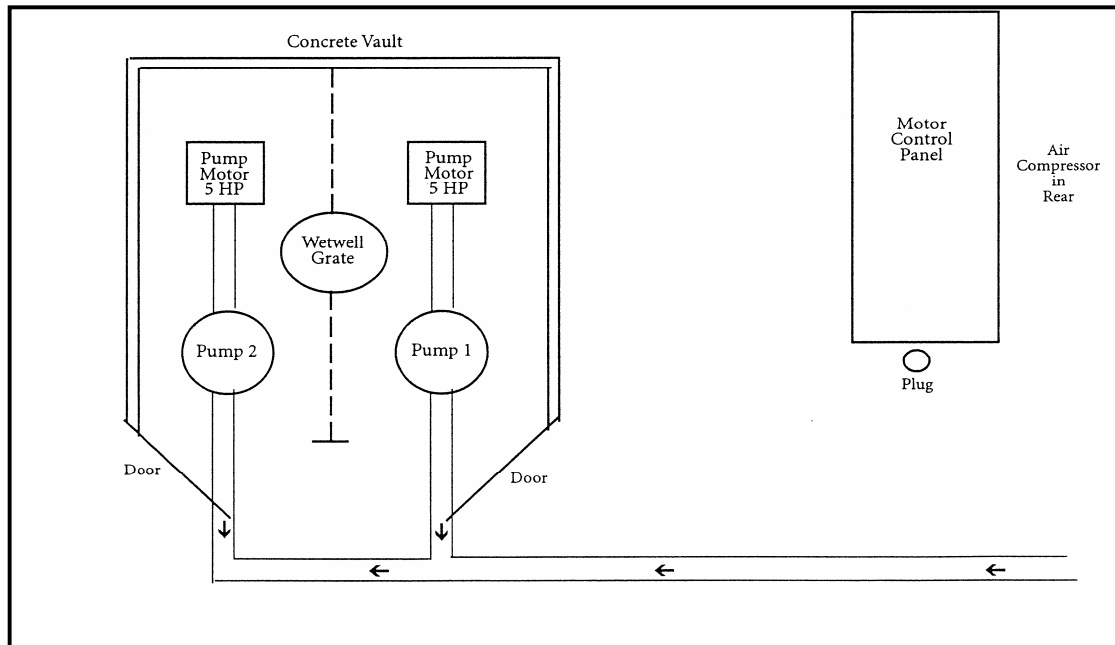
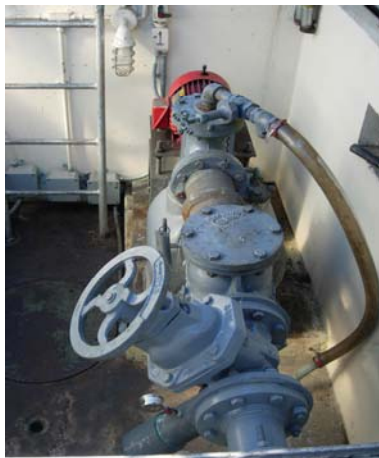
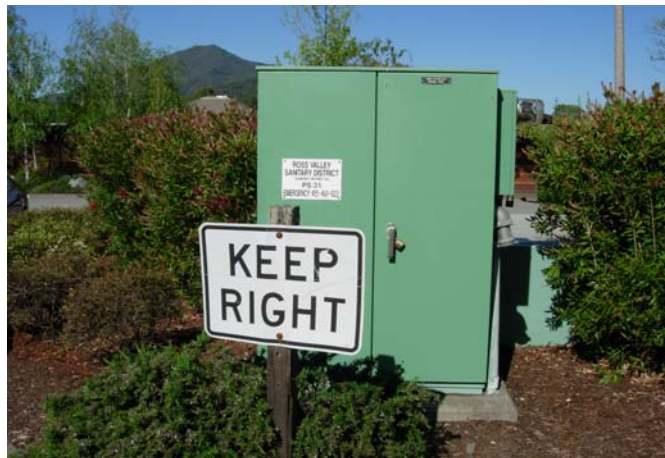
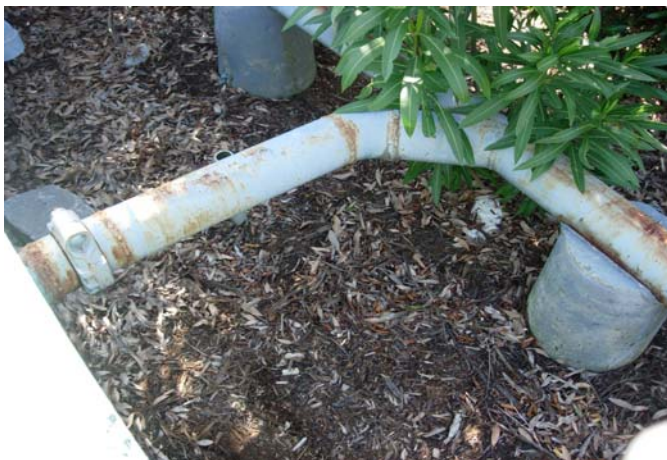
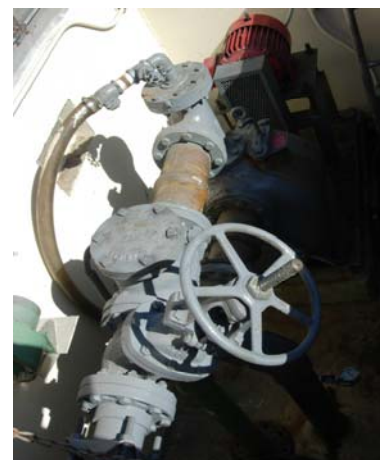
Field Visit Date	4/19/2006
PS Number & Name	31; 1 Via la Brisa
Address	1 Via La Brisa
Year Constructed; Improvements Past/Future	Mid-1960s
Number of Pumps/Number of Standbys	1/1
Pump Type	Dry-pit electric
Primary Power Source	PG&E
Standby Generator	Portable diesel powered 60 KW generator; 125 gal
Normal Operating Capacity (MGD)	Unknown
Firm Capacity (MGD)	Unknown
Operating Point (gpm/feet)	Unknown
Influent Sewer Size/Effluent Force Main Size	6"/6"
Horsepower Rating (hp)/Motor Speed (rpm)	5 hp
Pump Elevation (feet)	Unknown
Bypass capabilities	None
Notes	<ul style="list-style-type: none"> <li>• Flooding and infiltration/Inflow are an issue in the area. All joints are leaking. Pipeline built in 1964 on bay fill.</li> <li>• 6" FM exterior to be recoated (see Force Main Master Plan).</li> </ul>
Identified Issues	<ul style="list-style-type: none"> <li>• Existing pumps have to be primed.</li> </ul>
Recommendations	<ul style="list-style-type: none"> <li>• <b>Piping &amp; Valving:</b> Construct flow meter vault; Replace piping and valving as needed.</li> <li>• <b>Electrical:</b> NA</li> <li>• <b>Instrumentation &amp; Control:</b> Install flow meter. Install controls for new pumps. Connect to SCADA.</li> <li>• <b>Structural:</b> Modify valve pit and wet well.</li> <li>• <b>Health &amp; Safety:</b> Install ventilation system.</li> <li>• <b>Neighborhood Nuisance:</b> NA</li> <li>• <b>Pumps Improvement:</b> NA</li> <li>• <b>Influent Sewer/Force Main:</b> NA</li> <li>• <b>Maintenance/Reliability:</b> Replace existing pumps with submersible pumps.</li> </ul>

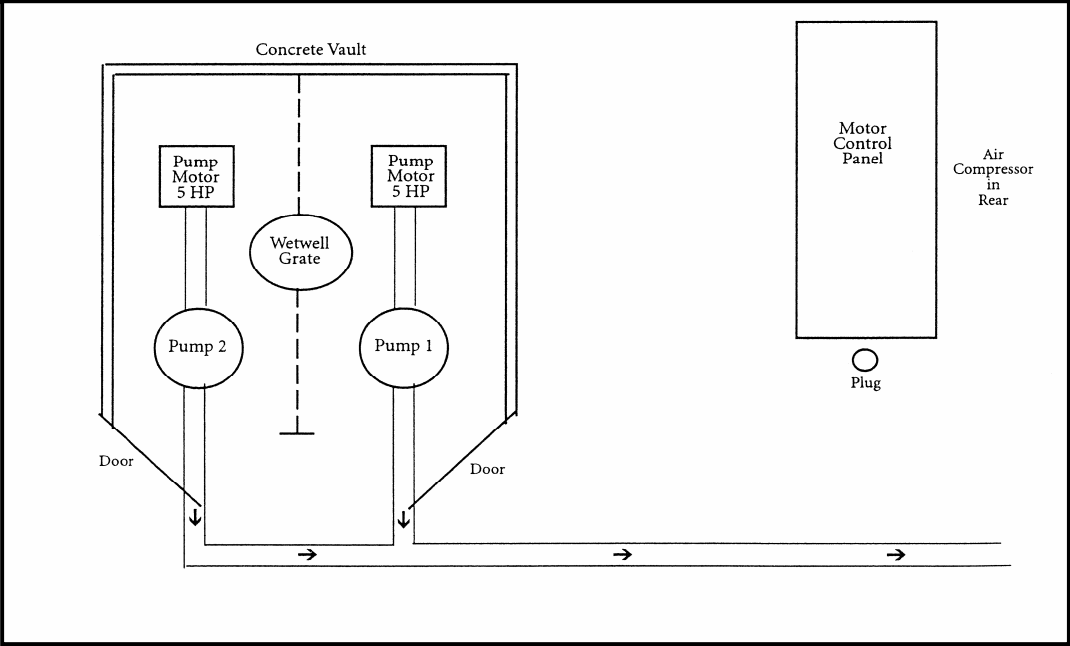
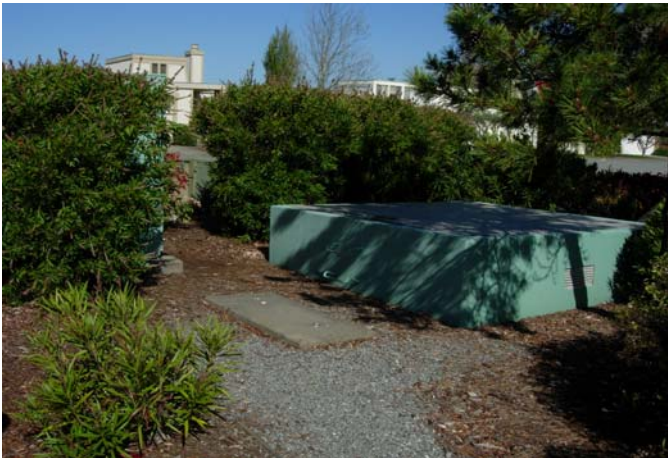
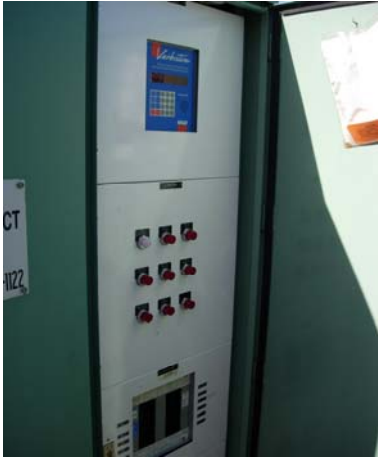
Field Visit Date	4/19/2006
PS Number & Name	32; 1 Corte del Bayo
Address	1 Corte del Bayo
Year Constructed; Improvements Past/Future	Mid-1960s
Number of Pumps/Number of Standbys	1/1
Pump Type	Dry-pit electric
Primary Power Source	PG&E
Standby Generator	Portable diesel powered 60 KW generator; 125 gal
Normal Operating Capacity (MGD)	Unknown
Firm Capacity (MGD)	Unknown
Operating Point (gpm/feet)	Unknown
Influent Sewer Size/Effluent Force Main Size	8"/5"
Horsepower Rating (hp)/Motor Speed	5 hp
Pump Elevation (feet)	Unknown
Bypass capabilities	None
Notes	<ul style="list-style-type: none"> <li>Flooding and infiltration/Inflow are an issue in the area. All joints are leaking</li> </ul>
Identified Issues	<ul style="list-style-type: none"> <li>Existing pumps have to be primed.</li> </ul>
Recommendations	<ul style="list-style-type: none"> <li><b>Piping &amp; Valving:</b> Construct flow meter vault; Replace piping and valving as needed.</li> <li><b>Electrical:</b> NA</li> <li><b>Instrumentation &amp; Control:</b> Install flow meter. Install controls for new pumps. Connect to SCADA.</li> <li><b>Structural:</b> Modify valve pit and wet well.</li> <li><b>Health &amp; Safety:</b> Install ventilation system.</li> <li><b>Neighborhood Nuisance:</b> NA</li> <li><b>Pumps Improvement:</b> NA</li> <li><b>Influent Sewer/Force Main:</b> NA</li> <li><b>Maintenance/Reliability:</b> Replace existing pumps with submersible pumps.</li> </ul>

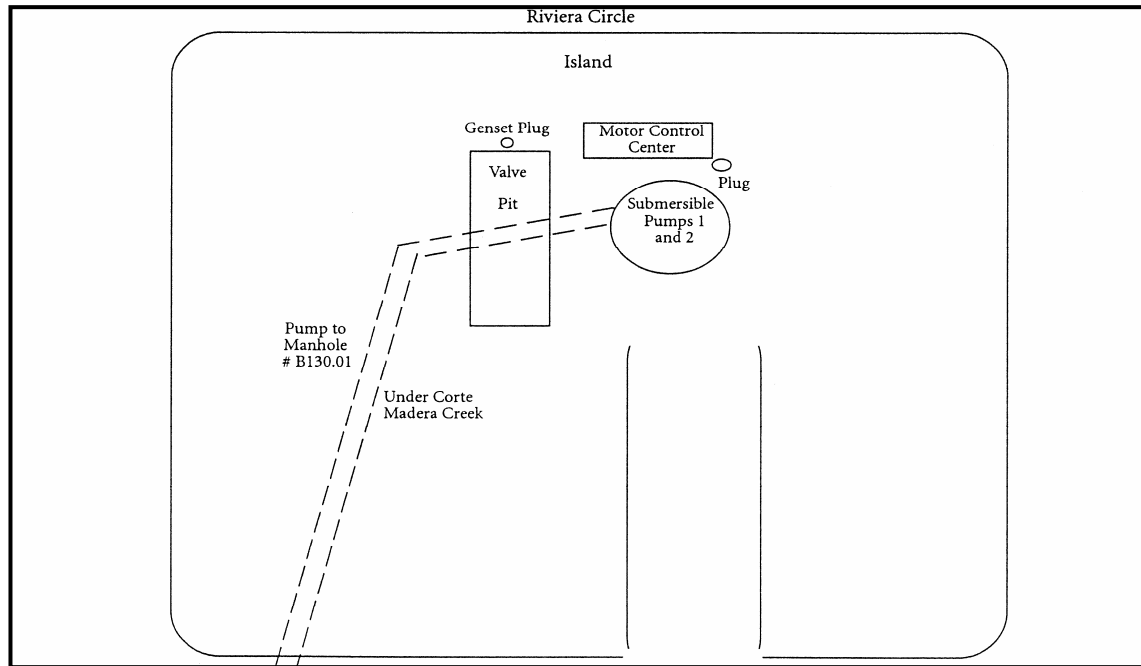
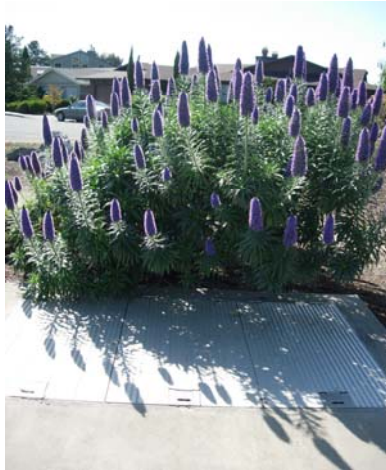
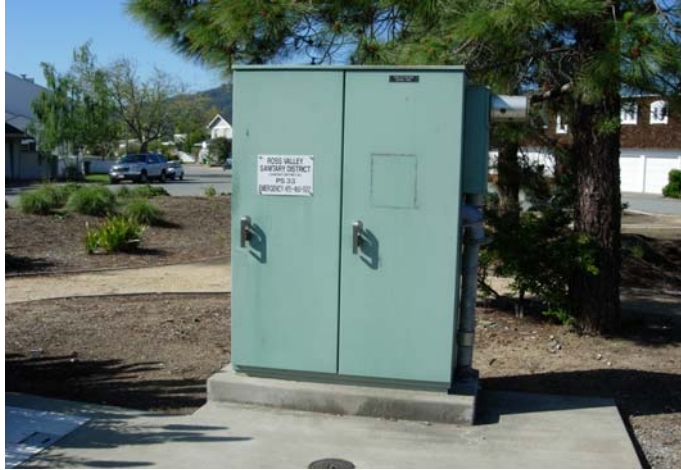
<b>Field Visit Date</b>	4/19/2006
<b>PS Number &amp; Name</b>	33; 415 Riviera Circle
<b>Address</b>	415 Riviera Circle, Larkspur
<b>Year Constructed; Improvements Past/Future</b>	Early 2000
<b>Number of Pumps/Number of Standbys</b>	1/1
<b>Pump Type</b>	Submersible
<b>Primary Power Source</b>	PG&E
<b>Standby Generator</b>	Portable diesel powered 60 KW generator; 125 gal
<b>Normal Operating Capacity (MGD)</b>	Unknown (Assumed 0.22 MGD)
<b>Firm Capacity (MGD)</b>	Unknown (Assumed 0.22 MGD)
<b>Operating Point (gpm/feet)</b>	150 gpm
<b>Influent Sewer Size/Effluent Force Main Size</b>	8"/6"
<b>Horsepower Rating (hp)/Motor Speed (rpm)</b>	5 hp
<b>Pump Elevation (feet)</b>	Unknown
<b>Bypass capabilities</b>	None
<b>Notes</b>	<ul style="list-style-type: none"> <li>• Flooding and infiltration/Inflow are an issue in the area. All joints are leaking.</li> <li>• Section of 6" steel FM in the mud needs to be replaced (approximately 300 feet) (see Force Main Master Plan).</li> </ul>

<b>Identified Issues</b>	<ul style="list-style-type: none"> <li>• None</li> </ul>
<b>Recommendations</b>	<ul style="list-style-type: none"> <li>• <b>Piping &amp; Valving:</b> Construct flow meter vault.</li> <li>• <b>Electrical:</b> NA</li> <li>• <b>Instrumentation &amp; Control:</b> Install flow meter. Connect to SCADA.</li> <li>• <b>Structural:</b> NA</li> <li>• <b>Health &amp; Safety:</b> NA</li> <li>• <b>Neighborhood Nuisance:</b> NA</li> <li>• <b>Pumps Improvement:</b> NA</li> <li>• <b>Influent Sewer/Force Main:</b> NA</li> <li>• <b>Maintenance/Reliability:</b> NA</li> <li>• <b>Overflow Potential:</b> NA</li> </ul>

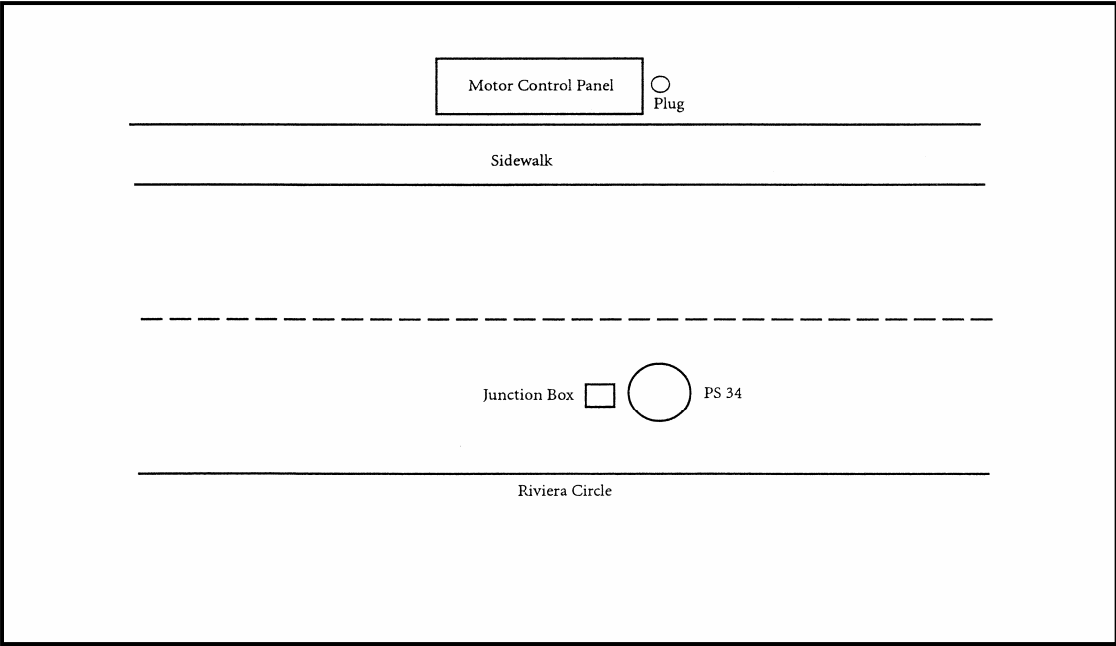
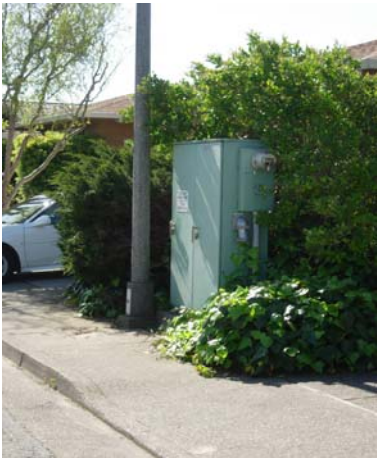
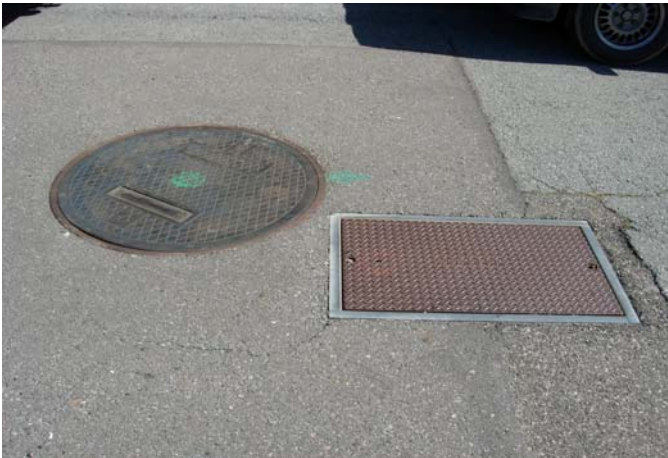
Field Visit Date	4/19/2006
PS Number & Name	34; 359 Riviera Circle
Address	359 Riviera Circle, Larkspur
Year Constructed; Improvements Past/Future	Mid-1960s
Number of Pumps/Number of Standbys	1/1
Pump Type	Submersible
Primary Power Source	PG&E
Standby Generator	Portable diesel powered 60 KW generator; 125 gal
Normal Operating Capacity (MGD)	Unknown (Assumed 0.22 MGD)
Firm Capacity (MGD)	Unknown (Assumed 0.22 MGD)
Operating Point (gpm/feet)	150 gpm
Influent Sewer Size/Effluent Force Main Size	8"/8"
Horsepower Rating (hp)/Motor Speed (rpm)	5 hp
Pump Elevation (feet)	Unknown
Bypass capabilities	None
Notes	<ul style="list-style-type: none"> <li>• Noise has been a problem for local residents. District has built a 6" force main parallel to the existing 8" line to address noise problem.</li> <li>• Flooding and infiltration/Inflow are an issue in the area. All joints are leaking.</li> </ul>
Identified Issues	<ul style="list-style-type: none"> <li>• Maintenance of station is difficult due to difficult access through necked-down manhole.</li> </ul>

Recommendations	<ul style="list-style-type: none"> <li>• <b>Piping &amp; Valving:</b> Install new piping and valving.</li> <li>• <b>Electrical:</b> NA</li> <li>• <b>Instrumentation &amp; Control:</b> Install flow meter. Install controls for new pumps. Connect to SCADA.</li> <li>• <b>Structural:</b> Modify wet well; Construct concrete pad.</li> <li>• <b>Health &amp; Safety:</b> NA</li> <li>• <b>Neighborhood Nuisance:</b> NA</li> <li>• <b>Pumps Improvement:</b> Install 2 new pumps.</li> <li>• <b>Influent Sewer/Force Main:</b> NA</li> <li>• <b>Maintenance/Reliability:</b> Rebuild new pump station including street vaults with wet well, rails and aluminum top.</li> <li>• <b>Overflow Potential:</b> NA</li> </ul>

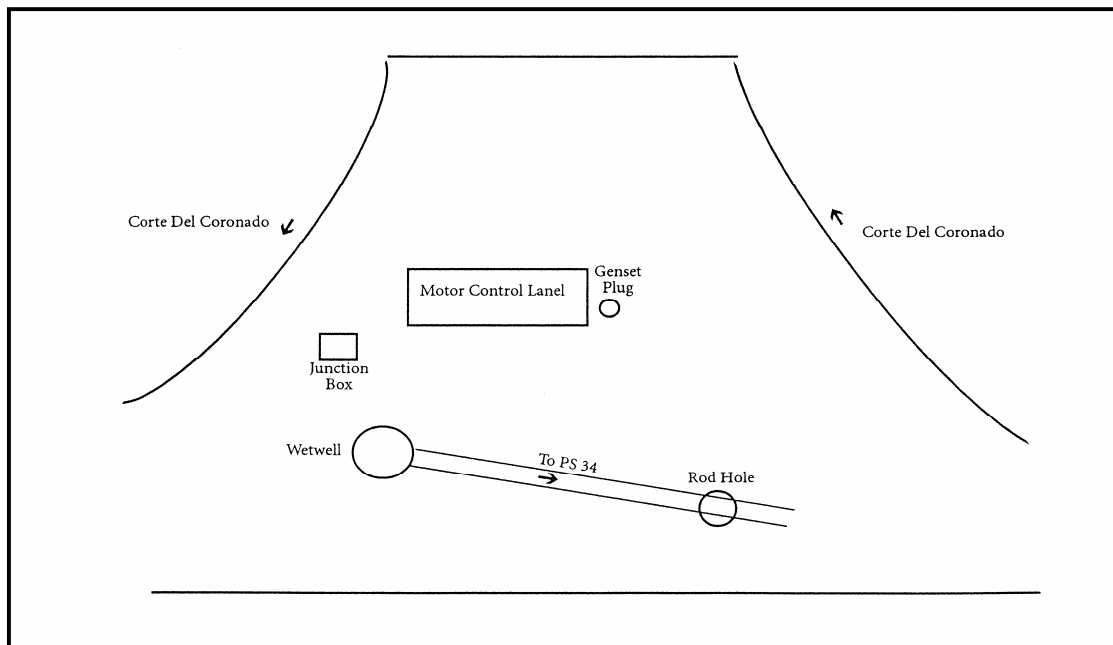
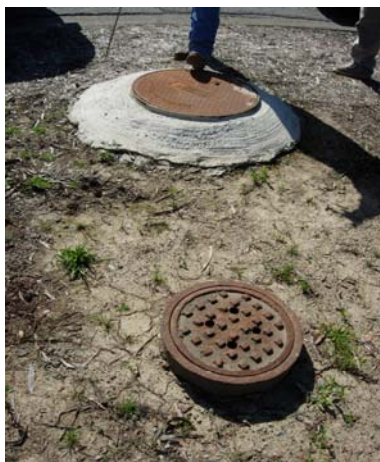
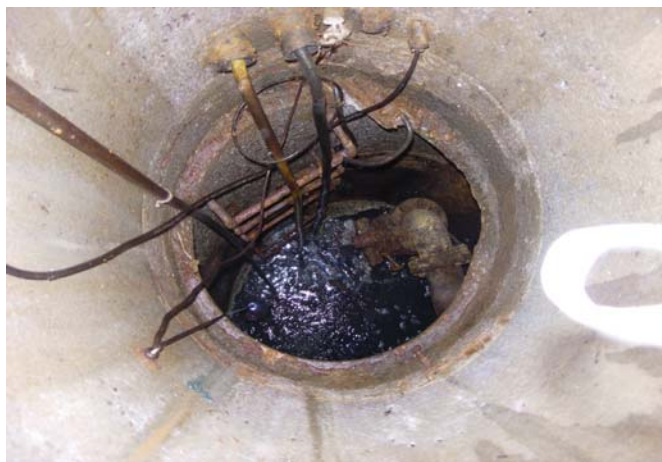
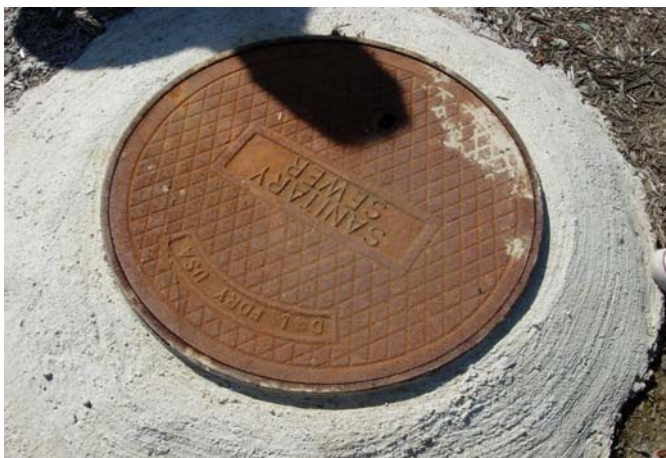
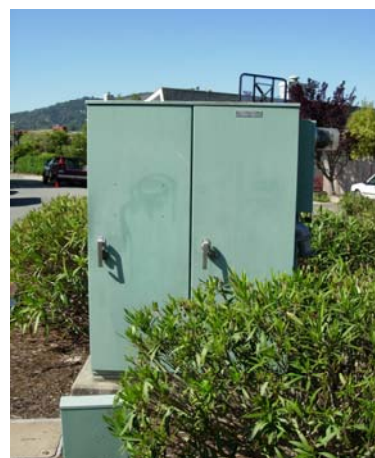
Field Visit Date	4/19/2006
PS Number & Name	35; 2 Corte del Coronado
Address	2 Corte Del Coronado
Year Constructed; Improvements Past/Future	Mid-1960s
Number of Pumps/Number of Standbys	1/1
Pump Type	Submersible
Primary Power Source	PG&E
Standby Generator	Portable diesel powered 60 KW generator; 125 gal
Normal Operating Capacity (MGD)	Unknown (Assumed 0.22 MGD)
Firm Capacity (MGD)	Unknown (Assumed 0.22 MGD)
Operating Point (gpm/feet)	150 gpm
Influent Sewer Size/Effluent Force Main Size	8"/8"
Horsepower Rating (hp)/Motor Speed (rpm)	5 hp
Pump Elevation (feet)	Unknown
Bypass capabilities	None
Notes	<ul style="list-style-type: none"> <li>• Flooding and infiltration/Inflow are an issue in the area. All joints are leaking.</li> <li>• Force main is ductile iron and clay.</li> </ul>
Identified Issues	<ul style="list-style-type: none"> <li>• Maintenance of station is difficult due to difficult access through necked-down manhole.</li> </ul>

Recommendations	<ul style="list-style-type: none"> <li>• <b>Piping &amp; Valving:</b> Install new piping and valving.</li> <li>• <b>Electrical:</b> NA</li> <li>• <b>Instrumentation &amp; Control:</b> Install flow meter. Install controls for new pumps. Connect to SCADA.</li> <li>• <b>Structural:</b> Modify wet well; Construct concrete pad.</li> <li>• <b>Health &amp; Safety:</b> NA</li> <li>• <b>Neighborhood Nuisance:</b> NA</li> <li>• <b>Pumps Improvement:</b> Install 2 new pumps.</li> <li>• <b>Influent Sewer/Force Main:</b> NA</li> <li>• <b>Maintenance/Reliability:</b> Rebuild new pump station including street vault with wet well, rails and aluminum top.</li> <li>• <b>Overflow Potential:</b> NA</li> </ul>

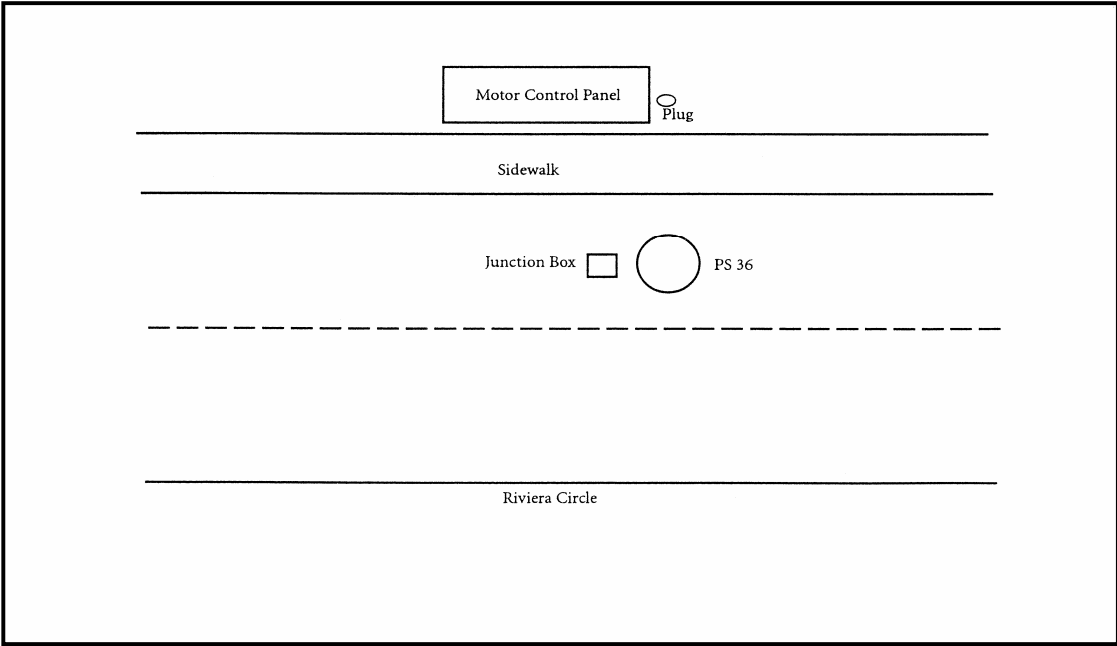
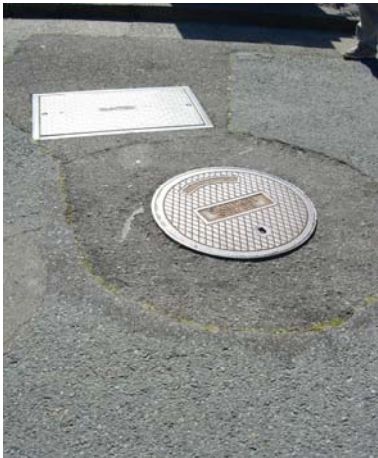
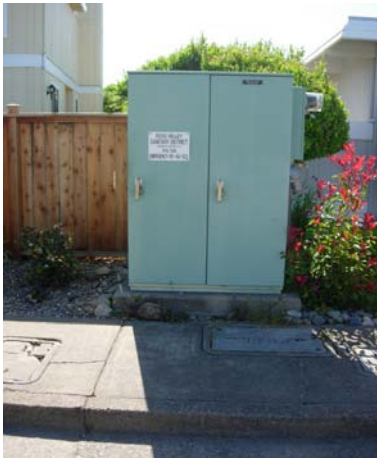
Field Visit Date	4/19/2006
PS Number & Name	36; 178 Riviera Circle
Address	178 Riviera Circle, Larkspur
Year Constructed; Improvements Past/Future	Mid-1960s
Number of Pumps/Number of Standbys	1/1
Pump Type	Submersible
Primary Power Source	PG&E
Standby Generator	Portable diesel powered 60 KW generator; 125 gal
Normal Operating Capacity (MGD)	Unknown (Assumed 0.22 MGD)
Firm Capacity (MGD)	Unknown (Assumed 0.22 MGD)
Operating Point (gpm/feet)	150 gpm
Influent Sewer Size/Effluent Force Main Size	8"/8"
Horsepower Rating (hp)/Motor Speed (rpm)	5 hp
Pump Elevation (feet)	Unknown
Bypass capabilities	None
Notes	<ul style="list-style-type: none"> <li>• Flooding and infiltration/Inflow are an issue in the area. All joints are leaking.</li> </ul>
Identified Issues	<ul style="list-style-type: none"> <li>• Maintenance of station is difficult due to difficult access through necked-down manhole.</li> </ul>
Recommendations	<ul style="list-style-type: none"> <li>• <b>Piping &amp; Valving:</b> Install new piping and valving.</li> <li>• <b>Electrical:</b> NA</li> <li>• <b>Instrumentation &amp; Control:</b> Install flow meter. Install controls for new pumps. Connect to SCADA.</li> <li>• <b>Structural:</b> Modify wet well; Construct concrete pad.</li> <li>• <b>Health &amp; Safety:</b> NA</li> <li>• <b>Neighborhood Nuisance:</b> NA</li> <li>• <b>Pumps Improvement:</b> Install 2 new pumps.</li> <li>• <b>Influent Sewer/Force Main:</b> NA</li> <li>• <b>Maintenance/Reliability:</b> Rebuild new pump station including street vault with wet well, rails and aluminum top.</li> <li>• <b>Overflow Potential:</b> NA</li> </ul>

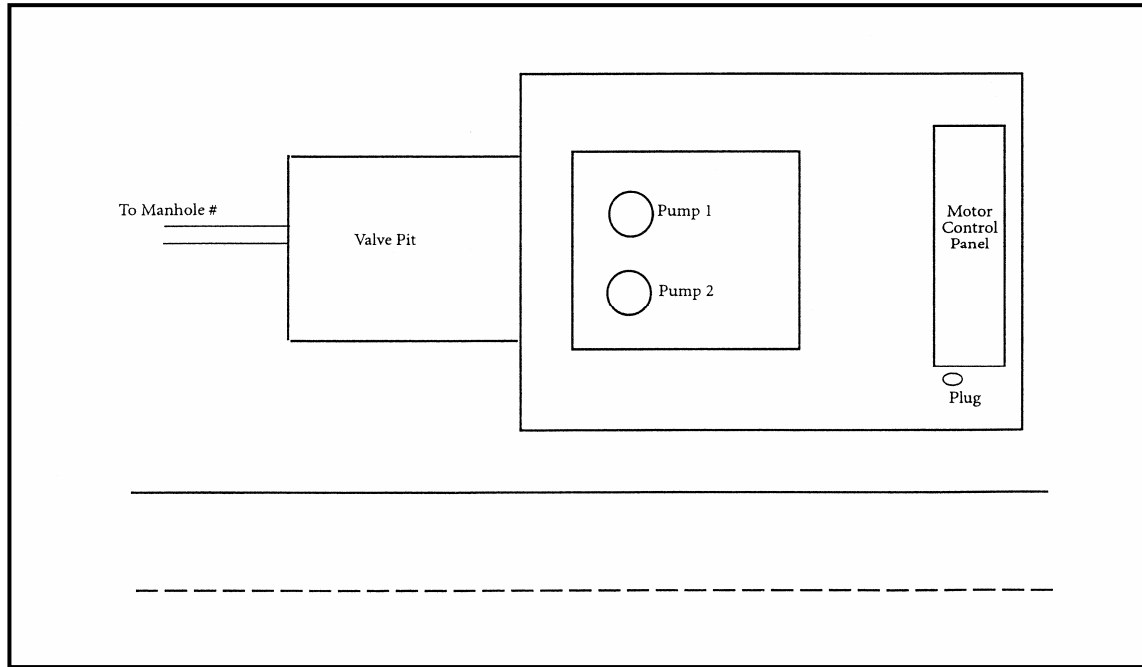
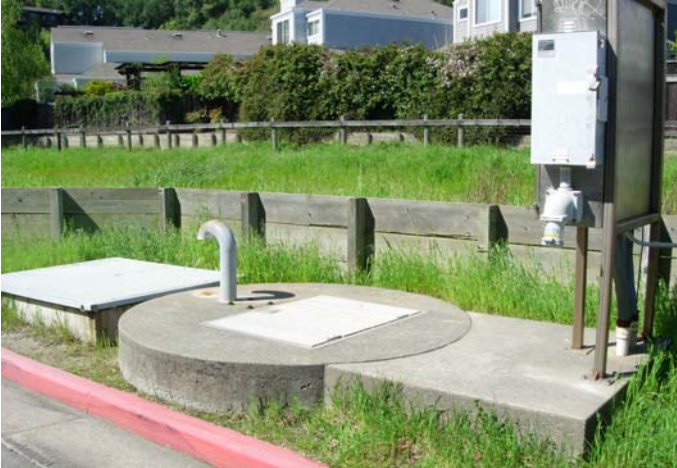
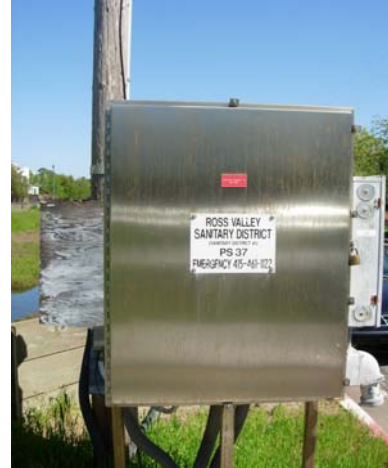
<b>Field Visit Date</b>	4/19/2006
<b>PS Number &amp; Name</b>	37; Larkspur Plaza
<b>Address</b>	Larkspur Plaza, across from Larkspur Plaza Drive, Larkspur
<b>Year Constructed; Improvements Past/Future</b>	-
<b>Number of Pumps/Number of Standbys</b>	1/1
<b>Pump Type</b>	Submersible
<b>Primary Power Source</b>	PG&E
<b>Standby Generator</b>	Portable diesel powered 60 KW generator; 125 gal
<b>Normal Operating Capacity (MGD)</b>	Unknown (Assumed 0.09 MGD)
<b>Firm Capacity (MGD)</b>	Unknown (Assumed 0.09 MGD)
<b>Operating Point (gpm/feet)</b>	60 gpm
<b>Influent Sewer Size/Effluent Force Main Size</b>	6"/4"
<b>Horsepower Rating (hp)/Motor Speed (rpm)</b>	3 hp
<b>Pump Elevation (feet)</b>	Unknown
<b>Bypass capabilities</b>	None
<b>Notes</b>	<ul style="list-style-type: none"> <li>• Station lost power in the 1990s for 3 days. When flooding, all sewers overflow to PS 14 through gravity line.</li> <li>• Grease problem in sewer.</li> </ul>

<b>Identified Issues</b>	<ul style="list-style-type: none"> <li>• Defective valving system.</li> <li>• District and City of Larkspur share 3-line power. It is recommended that City of Larkspur and District have separate power lines.</li> <li>• Area subject to frequent flooding.</li> </ul>
<b>Recommendations</b>	<ul style="list-style-type: none"> <li>• <b>Piping &amp; Valving:</b> Replace valves.</li> <li>• <b>Electrical:</b> Construct separate power line for District pump station.</li> <li>• <b>Instrumentation &amp; Control:</b> Install flow meter. Connect to SCADA.</li> <li>• <b>Structural:</b> NA</li> <li>• <b>Health &amp; Safety:</b> NA</li> <li>• <b>Neighborhood Nuisance:</b> NA</li> <li>• <b>Pumps Improvement:</b> NA</li> <li>• <b>Influent Sewer/Force Main:</b> NA</li> <li>• <b>Maintenance/Reliability:</b> NA</li> <li>• <b>Overflow Potential:</b> NA</li> </ul>
